Fukushima 1st NPPs Accidents and Disaster Caused by the Pacific Coast Tsunami of Tohoku Earthquake

–Lessons from Evaluation of the Fukushima 1st NPPs Accidents–

Hokkaido University, **Tadashi Narabayashi and Kenichiro Sugiyama**

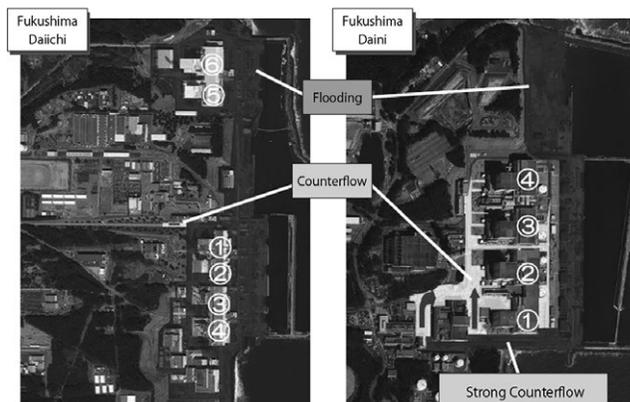
(b) Flooding and retroactive flow area after the tsunami (Fukushima Daiichi, Fukushima Daini)¹⁾

Figure 2 (b) shows a comparison of the areas in Fukushima Daiichi and Daini Power Stations where flooding or retroactive flow was observed after the tsunami. The flooded area of Daiichi was larger, and as shown in **Figure 3**, it experienced station blackout caused by the loss of external power supplies and the unavailability of the EDG due to seawater infiltration.

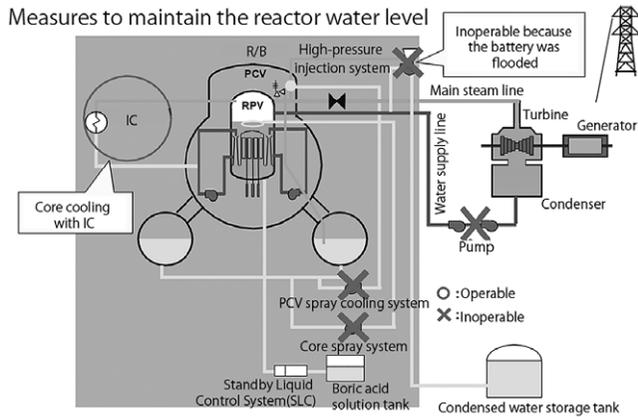
(a) Core cooling by IC during the station blackout immediately after the tsunami

This unit comprises one turbine-driven HPCI, two low-pressure CS as ECCS, and two ICs for RCIC, equipped in BWR/3. As shown in **Figure 10** (b), soon after the scram by the earthquake, two EDGs were started by a loss in the external power and HPCI was also started. The decay heat removal and depressurization in RPV were conducted using two ICs that started automatically at +7.1 MPa. Every cooling system was under good operation before the attack of tsunami. Unfortunately, cooling rate exceeded 55°C/h (100°F/h), and two ICs were stopped manually about 19 min after scram by an operator to meet the safety guide rule. Then, the operator adjusted the pressure near 7 MPa by opening and closing the IC exit valve. When the tsunami came, the IC exit valve was closed, and the Unit 1 lost its entire cooling system.

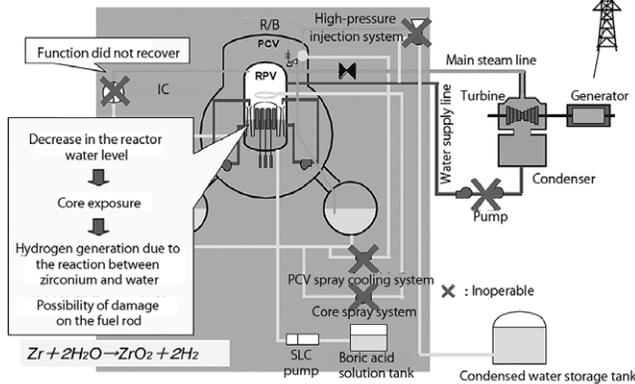
(b) Core exposure and hydrogen generation after IC stopped working

Reactor water level decreased due to the cooling function loss of IC, followed by the exposure of the core

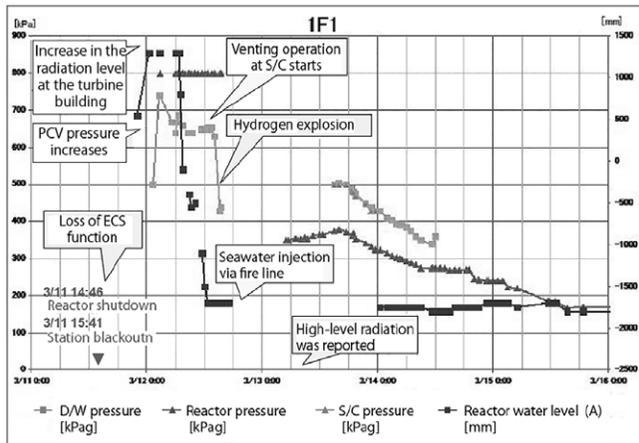
Figure 11 Time transition of the key parameters after the earthquake at Fukushima Daiichi Unit 1³⁾

The RPV pressure was kept as 7 MPa by SRV's safety mode, and steam was exhausted into S/P. Under such condition, water level should be decreased but the reactor water level (■) increased at about 24:00 on March 11, as shown in **Figure 11**. This means that the temperature in PCV exceeded more than 300°C by core damage and water in a reference leg of water level measurement system decreased by vaporization. At the same time, PCV pressure increased and reached 750 kPa, near 2Pd (2 times the design pressure of PCV) at 3:00 on March

12 (Figure 11). At 6:00, the PCV pressure decreased to 650 kPa. This means the leakage of vapor mixed with fission products (FPs) through top flange of PCV started. Indeed, the radiation level in the power station site started to increase, as shown in **Figure 12**. Moreover, the hydrogen from the zirconium water reaction was mixed in the steam. The hydrogen rose to the top floor in the R/B, where the shield plug, at the center of the operation floor, leaks the hydrogen through the gap around the circumference of the shield plug (about 20 mm), and started to accumulate in the operation floor.

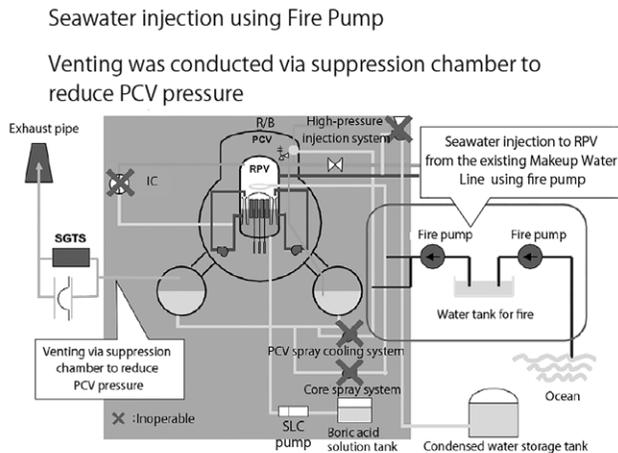
Figure 13 Severe accident mitigation measures at Unit 1¹⁾

Meanwhile, at Unit 1, the severe accident mitigation measures stipulated in accident management (AM) were conducted (**Figure 13**). Water injection to core using mobile power generator and fire pump was conducted. First, fresh water injection was conducted using a CS system line connected to the firefighting system line and water from the firefighting tank while removing the vast amount of debris brought by the tsunami. At this point, it was necessary to conduct depressurization of RPV through the SRV used for the automatic depressurization system (ADS) because the discharge pressure of the fire pump, which was approximately 1 MPa, was not enough to inject water into the RPV of 7 MPa. Due to the station

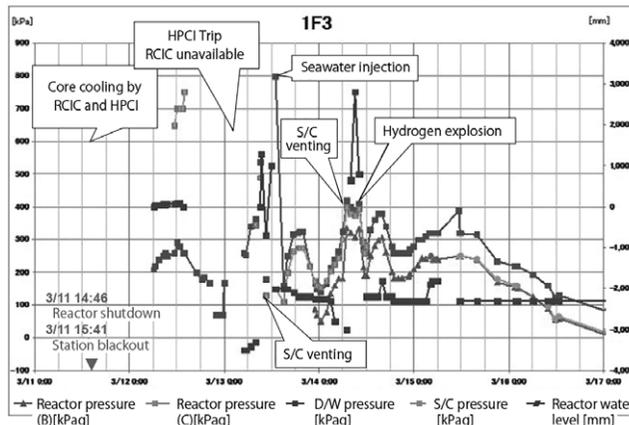
Figure 15 Time transition of Unit 3 after the accident ¹⁾

As shown in **Figure 15**, steam turbine-driven RCIC and HPIS continued to function at Unit 3 after the tsunami. However, possibly due to the issue with the freshwater source, water injection became no longer possible at 5:00 on March 13. During this time, the water level decreased to -3000 mm but temporally recovered after the depressurization operation of ADS. By 13:00 on March 12, the pressure in the suppression chamber reached approximately 780 kPa. It is assumed that this caused deformation of the top flange of PCV, which in turn led to a leakage of steam, which includes hydrogen that accumulated in the upper part of R/B for about 2 days. At 11:01 on March 14, a violent hydrogen explosion accompanied by black smoke blew up the upper part of R/B and caused the deformation of the walls of the operation floor and the steel frames of the roof to the extent that the original shape was unrecognizable.

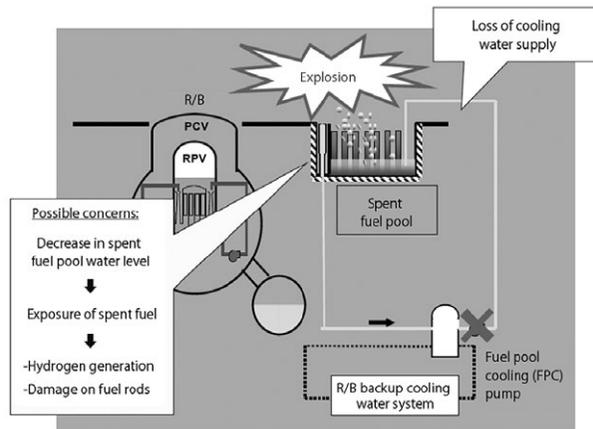
Figure 16 Concerns for spent fuel pool when external power source is lost¹⁾

As the exchange work of shroud in conjunction with a periodic inspection was undergoing, all 1331 spent fuels and new 204 fuels, which were planned to be installed, were inserted into the rack in the spent fuel pool. At 6:14 on March 15, hydrogen explosion occurred and blew up the earthquake-proof class A walls of the 3rd and 4th floors of R/B (reinforced concrete wall, 50 cm thick) as well as the concrete wall of the 5th floor and roof. However, the yellow paint coating of the top flange of PCV and green paint coating of the fuel exchanger were not burned. Thus, it is assumed that a detonation where a shock wave passes through in an extremely short time occurred. After the accident, there was enough water in the spent fuel pool to cover the fuel, which is supposed to be in the state as shown in **Figure 16**. However, it has

not been quantitatively explained. Since the reactor and equipment wells were filled with water, we assume that the partition panel between the spent fuel pool and reactor well came off due to an impact of the hydrogen explosion, which caused the water to flow from the reactor well to spent fuel pool. However, examination and verification are required to check whether the water in the spent fuel pool is sufficient to cool all the spent fuels after the earthquake.
