Measures to Improve Robustness of Primary Containment Vessel and Operation of Filtered Containment Venting System Based on the Lessons from the Containment Leak at Fukushima Dai-ichi Nuclear Power Station Unit 2

Shinichi KAWAMURA ^{1,*}, Suguru OOKI ² and Tadashi NARABAYASHI ³

¹*Nuclear Asset Management Department, Tokyo Electric Power Company, 1-1-3 Uchisaiwai-cho, Chiyoda-ku, Tokyo 100-8560, Japan*

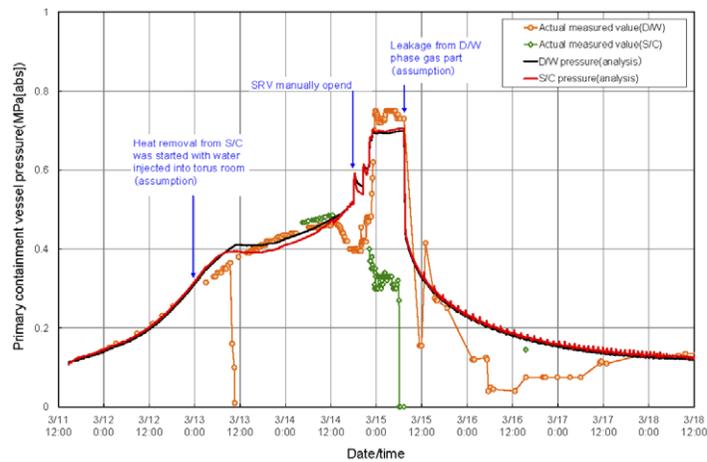
The measured dry well pressure value of Unit 2 increased rapidly at around 22:40 on March 14 and then decreased significantly between 7:00 and 11:00 on March 15. The air dose rate near the main gate of Fukushima Dai-ichi increased rapidly from approximately 0.1 mSv/h to 10 mSv/h around the same time, but PCV venting was not conducted in Units 1 and 3 during that time. Therefore, it is believed that the PCV of Unit 2 lost its containment function around that time.

On the afternoon of March 14, the measured pressure values of the suppression chamber and dry well became significantly separated from each other and the measured pressure value of the suppression chamber decreased. Since both sections are connected via vent pipes, such separation does not occur as an actual phenomenon and is considered to be a result of a failure of the pressure indication of the suppression chamber.

The maximum pressure in the PCV measured before loss of the PCV function was approximately 0.75 MPa [abs] and did not reach 0.95 MPa [abs], the pressure limit for maintaining function (twice the maximum working pressure) assumed before the accident. In addition, the

Figure 1 Pressure trend of the PCV at Fukushima Dai-ichi Unit 2¹⁾
D/W and S/C refer to the “dry well” and “suppression chamber” of the PCV respectively. SRV refers to the “safety relief valve.”

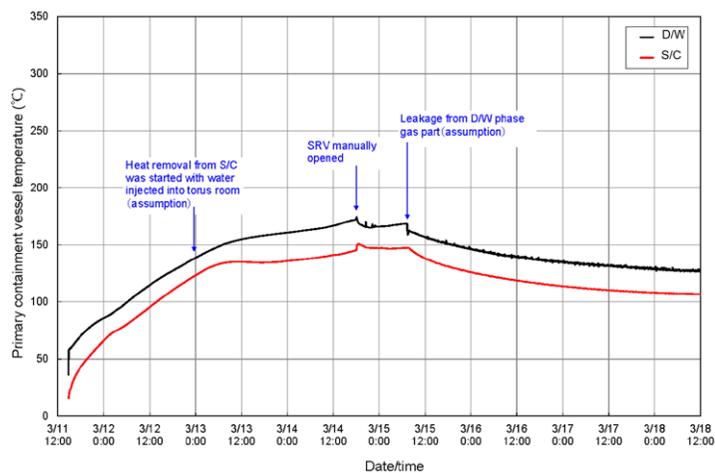
Figure 2 Temperature trend of the PCV at Fukushima Dai-ichi Unit 2¹⁾
D/W and S/C refer to the “dry well” and “suppression chamber” of the PCV respectively. SRV refers to the “safety relief valve.”

maximum analytical value of the temperature in the PCV evaluated using MAAP code before loss of the containment function was approximately 175°C and did not reach 200°C, the assumed temperature limit for maintaining function before the accident.

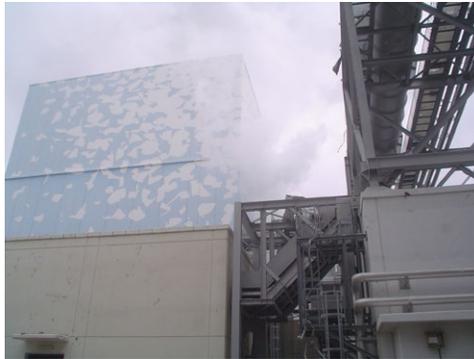
As mentioned above, loss of the containment function of the PCV of Unit 2 occurred between 7:00 and 11:00 on March 15. **Figure 3** shows a photograph of Unit 2 taken on March 15. This photograph shows the steam discharged from the opening of a blow-out panel on the top

Figure 3 Steam coming out of a blow-out panel opening at the Fukushima Dai-ichi Unit 2 Reactor Building on March 15, 2011

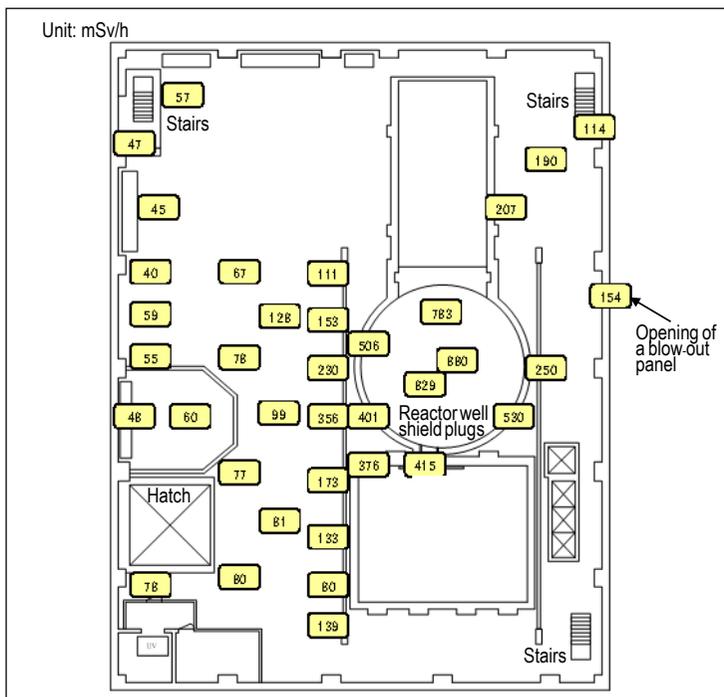
In addition, according to the dose rate distribution on the 5th floor shown in Figure 4, the

Figure 4 Spatial radiation dose rate on the 5th floor of the Fukushima Dai-ichi Unit 2 Reactor Building

dose rates measured above the shield plug of the reactor well were higher than those measured in the surrounding area. On the other hand, the dose rates measured at the stairs connecting the 5th floor and the lower floor and near the hatch are lower than those measured above the shield plug. Furthermore, comparing the dose rates between the stairs on the 5th and 4th floors (Refer to Figure 5) and between the hatch on the 5th and 4th floor, they were higher on the 5th floor. Therefore, it seems unlikely that the leakage occurred on a lower floor and the radioactive materials reached the 5th floor through the stairs and the hatch opening and were then released into the atmosphere from the opening of the blow-out panel. Although the dose rate was not measured at the stairs shown on the lower right of the Figure, it is highly unlikely that the leakage occurred on a lower floor and the radioactive materials reached the 5th floor through the stairs because the stairs on the 4th and 3rd floors (Refer to Figure 6) passed between the shield wall of the spent fuel pool and the outer wall of the reactor building, creating no leakage path from the PCV. Additionally, the dose rate measured on the 2nd floor (Refer to Figure 7) was lower than that of the 5th floor. These investigation results suggest the possibility that a large amount of the radioactive material leaked from the PCV head flange directly beneath the shield plug of the reactor well.

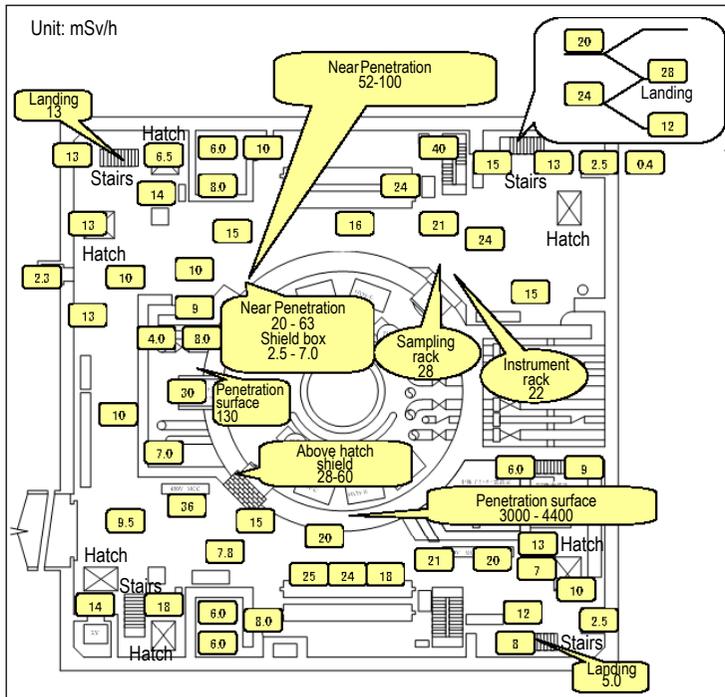
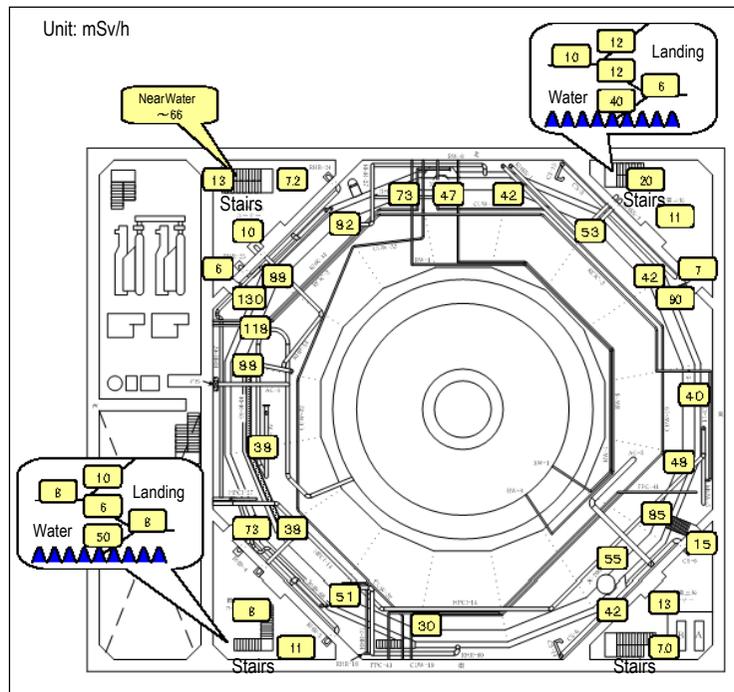
Figure 8 Spatial radiation dose rate on the 1st floor of the Fukushima Dai-ichi Unit 2 Reactor Building

Figure 9 Spatial radiation dose rate in the middle basement of the Fukushima Dai-ichi Unit 2 reactor building

Furthermore, Figures 8 and 9 show the dose rate distributions on the 1st floor and the middle basement, but the dose rates measured at the stairs and hatches were lower than those measured on the 5th floor, so it seems unlikely that they became advection paths for radioactive materials. Although high dose rates were measured near the PCV penetrations on these floors, the dose rates measured in the surrounding rooms and corridors were low. This is believed to be because of the influence of the radiation that transmitted from inside the PCV pressure boundary; however, significant leakage did not occur in these places.

The water containing radioactive materials was retained in the triangular corner areas of the four corners of the reactor building shown in Figure 9. If a leakage occurred in the PCV or a system connected to the PCV such as the reactor core isolation cooling (RCIC) system in these areas, the containment function would have been lost, the PCV would depressurize, and the radioactive materials injected at high pressure would have spread high-concentration contamination to these triangular corner areas and stairs. However, the dose rates measured at those places were low, and the dose rates measured at the stairs increased with elevation. Therefore, the cause of the contamination of the retained water was distinct from the leakage that occurred when the containment function was lost—the contamination occurred after that.

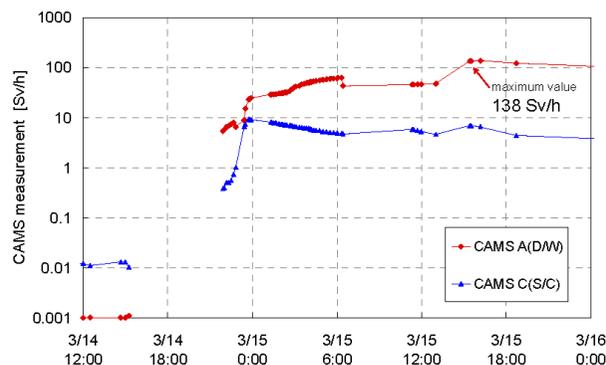
It could be also confirmed from the increase in the measurements of the containment atmospheric monitoring system (CAMS) that the core damage progressed after water injection into the reactor was resumed by a fire engine. **Figure 10** shows the changes in the measurements of CAMS from 12:00 on March 14 to 0:00 on March 16. After water injection until around 0:00 on March 15, the measurements increased rapidly both in the dry well and the suppression chamber. This is believed to be a result of the rapid progress of the zirconium-water reaction due to water injection that caused the generation of a large amount of hydrogen and the release of fission products due to core damage. They were transferred to the suppression chamber via the main steam safety relief valves and to the dry well via the vacuum break valves. The reason why the indicated value of the suppression chamber is smaller than that of the dry well is because the CAMS on the suppression chamber side measure the dose rate outside the PCV.

Because the CAMS was unable to make measurements between 7:00 and 11:00 on March 15, when the PCV lost its containment function, the trend during that period is unknown. However, between 6:20 and 6:25, before measurement failure, the CAMS measurement of the dry well decreased rapidly from 62.7 Sv/h to 43.0 Sv/h; it may have captured loss of the containment function in the dry well as well as the leakage into the reactor building, which is consistent with the above estimation that the containment function was lost due to leakage from the top head of the PCV. The CAMS measurement recorded its highest value at 16:10 on March 15, possibly due to the continuous progress of core damage that resulted in the relocation of the damaged core and breakage of the reactor.

Figure 10 CAMS of the Fukushima Dai-ichi Unit 2 from March 14 to March 16, 2011

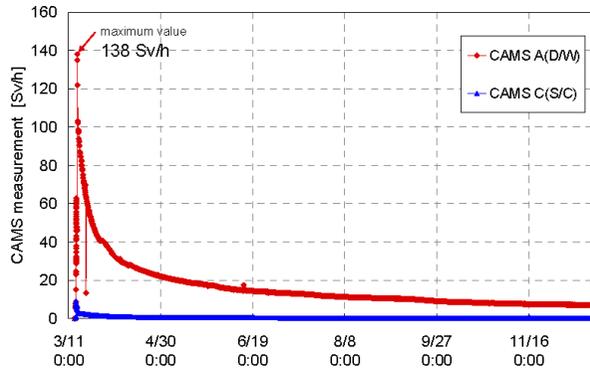
As **Figure 11** shows, the CAMS measurement in Unit 2 decreased monotonically after it reached its peak at 16:10 on March 15. This indicates that continuous water injection cooled the fuel debris, which led to the suppression of the additional release of fission products.

Figure 11 CAMS of the Fukushima Dai-ichi Unit 2 from March to November 2011
 D/W refers to the “dry well” and S/C refers to the “suppression chamber” of the PCV.

Therefore, continuing water injection to cool fuel debris and reduce the pressure in the PCV, even after it loses its containment function, is considered to be an effective mitigation measure.

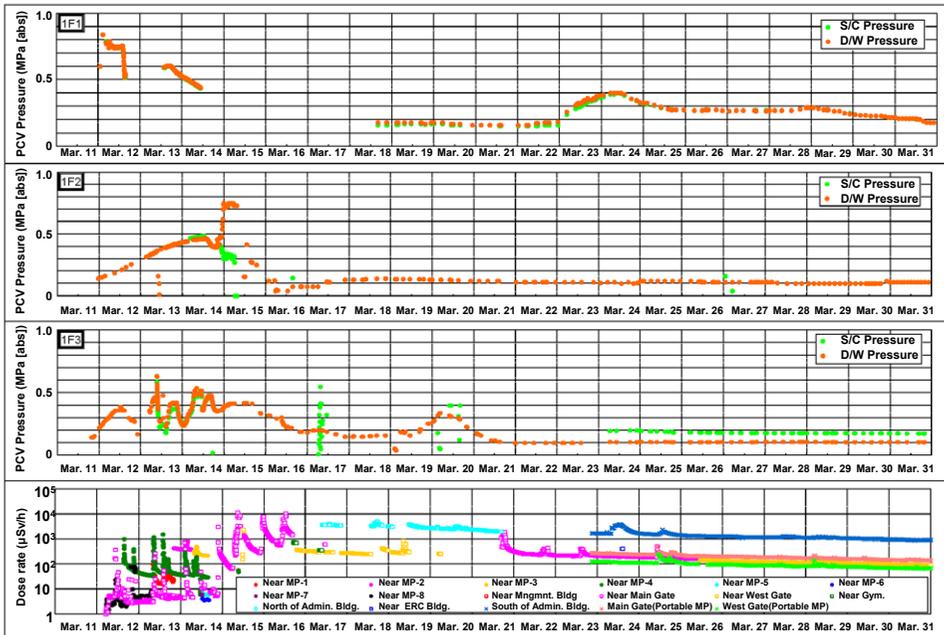
Figure 12 The PCV pressures of Units 1, 2 and 3 (1F1, 1F2, and 1F3, respectively) as well as environmental radiation¹⁾

The changes in the dose rate measured at the Fukushima Dai-ichi site and the changes in the PCV pressures of Units 1, 2 and 3 are as shown in **Figure 12**¹⁾. It shows that continuous water injection reduced the dose rate almost monotonically on and after March 26 and the situation where a large amount of additional radioactive material could have been released into the atmosphere was avoided. In addition, the pressure in the PCV was stabilized through continuous water injection.

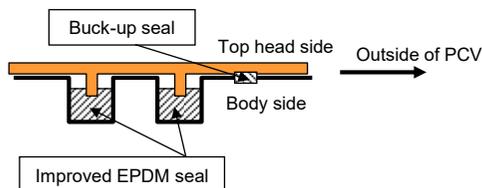
Figure 13 Seal arrangement of the PCV top head flange

For the purpose of maintaining leakage resistance performance under a high-temperature steam condition in the event of a severe accident, the material of the gasket used for the top head flange of the PCV was changed from conventional silicone rubber to improved ethylene-propylene-diene rubber (improved EPDM)⁴⁻⁶⁾. The material possesses superior steam and radiation resistance and exhibited no deterioration-related behavior at the iodine concentration assumed to be present in a severe accident. Since the flange gasket of the hatches and the valve seals of the PCV were also made of silicone rubber, it was determined that improved EPDM should be utilized for these as well.

Furthermore, a backup sealing material (silicone-based one-component fire-resistant sealant) was added to the top head flange and the hatches^{4,7)}. This sealing material was applied to the flange surface located outside the gasket mounting groove. Although the leakage resistance performance was maintained by the gasket while a pressure higher than the maximum working pressure was applied to the PCV in a severe accident, the backup sealing material is intended to enhance the long-term maintenance of leakage resistance performance after the PCV pressure has been decreased through containment venting, etc. Even if the flange remains at high temperatures for a long time after the accident, the backup sealing material can maintain its leakage resistance performance independently and is also expected to reduce oxidation degradation of the improved EPDM gasket by blocking external air.

Figure 13 presents a diagram of the conceptual layout of the sealants in the top head flange of the PCV. They are arranged in the same way in the hatch flanges.

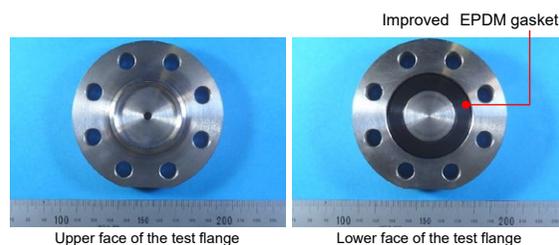
Figure 14 shows the external appearance of the simulated flange used for the test. The seal groove of the simulated flange and the section size of the mounted sealing material were half those of the actual system. In addition, a step was provided inside the simulated flange to simulate a situation where the PCV is pressurized and the flange is opened in the event of an accident, and the sealing material was exposed to high-temperature steam while mounted on the flange. After it was exposed to a predetermined environment in the autoclave, it was pressurized by helium to check its airtightness.

Figure 14 Test flange and improved EPDM gasket

it by 0.8 mm using a jig after exposure to high temperature, considering that the flange opens when it is pressurized in the event of an accident. Since the section sizes of the simulated flange and gasket used in this test are half of those used in an actual system, an opening of 0.8 mm in the test system corresponded to the 1.6 mm opening in an actual system. In the case of a PCV in an advanced BWR (ABWR) plant, the flange of the equipment hatch has the largest opening displacement when the pressure doubles the maximum working pressure in the event of an accident. Although the displacement becomes larger on the inner gasket side than on the outer gasket side, it was approximately 1.4 mm on the inner gasket side, which is within the range of the opening condition set in this test. No leakage was observed in this test and it was confirmed that airtightness was maintained through the resiliency of the sealing material (which was compressed in advance and installed) even if an opening was created when the PCV was pressurized at a pressure double the maximum working pressure.

In addition, as a result of checking the external appearance of the sealing material after the test, no abnormalities such as cracks were observed on the surface.

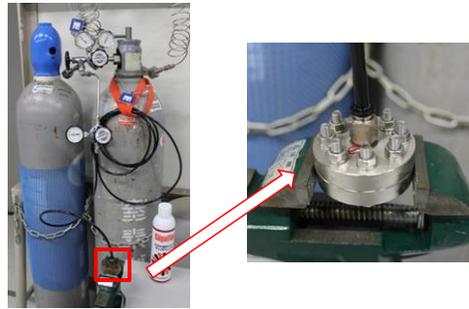
We also conducted environmental qualification test of the backup sealing material. In this test, the simulated flange to which the backup sealing material was applied was irradiated with γ -rays of 800 kGy or higher to simulate the accumulated radiation dose seven days after an accident, and it was exposed to a steam environment of 250°C for 168 hours. Then, it was pressurized up to 0.9 MPa with helium to check airtightness. **Figure 15** shows the condition of the airtightness test and **Table 2** shows the test results. In an actual system, the backup sealing material is used in combination with a gasket made of improved EPDM. However, in this test, only the sealing material was applied, and the gasket was not mounted to confirm the performance. The retention times for each pressure in the airtightness test were ten minutes at 0.3 MPa and thirty minutes at 0.65 MPa and 0.9 MPa. During each retention period, no bubble generation was observed in the leakage check using bubble solution and no pressure drop was observed. And the results demonstrated superior airtightness.

Figure 15 Air tightness test of back-up seal using helium

generation or pressure drop was observed in the leakage confirmation conducted using bubble solution, and superior airtightness was demonstrated. This test confirmed that the leakage resistance performance can be expected to be maintained for long periods after an accident.

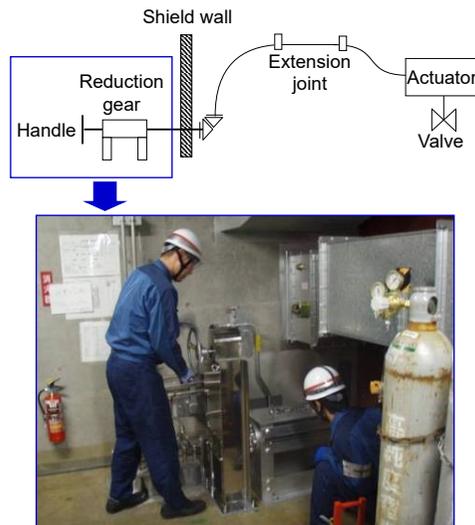
In addition, in Unit 2, the pressure inside the PCV could not be relieved before loss of the containment function of the PCV because one of the valves of the containment venting system could not be kept in the open position and the operation for opening the closed valve failed. Since the valve was air-operated and the solenoid valve which controlled the air was designed to be operated remotely from the main control room, there was no on-site feature for opening and closing the valves. Therefore, in addition to remote operation from the main control room, a feature that enables the on-site, hand operation of the valves for containment venting should be provided so that venting can be conducted at any time. **Figure 16** shows an example in which the valve operating mechanism was extended to outside the secondary containment, where the radiation level is low even in the event of an accident so that the valve can be operated

Figure 16 Example of a manual operation device for a valve in the filtered containment venting system installed outside the secondary containment boundary

manually and kept open. This feature can be incorporated into both motor-operated valves and air-operated valves that have a ratchet mechanism in their drive mechanisms.
