Radiological Safety Survey of Diagnostic Medical X-ray Machines Use in Private and Public Medical Facilities in Malaysia

Y. M. Amin^{1*}, M. N. Rifiat², A. F. A. Razak² and A. Lawai²

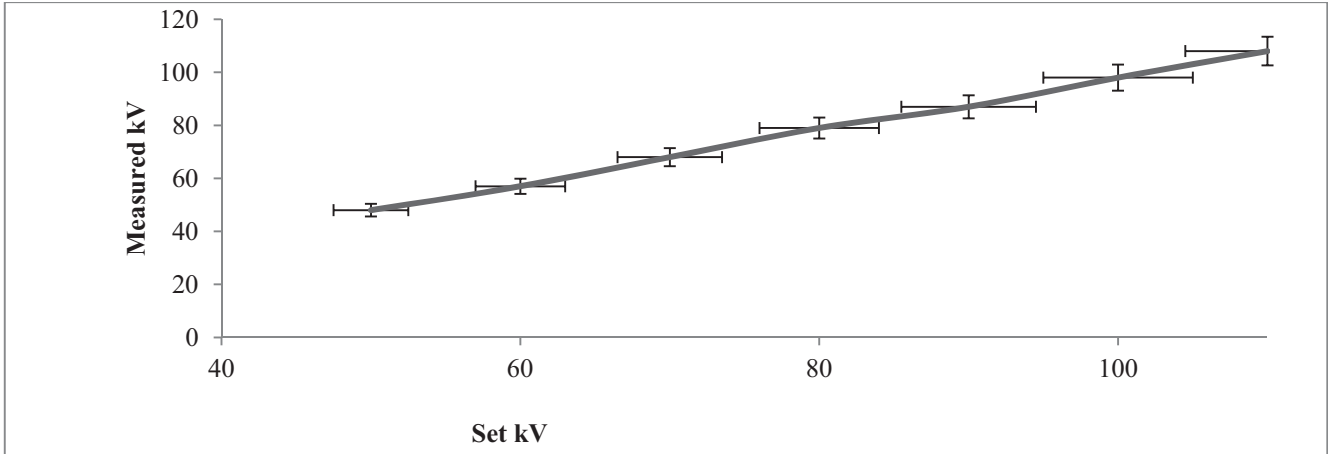
For testing the kV accuracy, the kV is set from 50 kV to 110 kV at 10 kV intervals and the operating current is 100 mA. **Figure 1** shows the typical kV accuracy plot. The number of machines that conforms to MS 838 is 97% as shown in **Figure 2**. The number of machines having exposure and output linearity that conforms to the standard is indicated in **Figure 3**. There are 2 machines having output

Fig. 1 A plot of set voltage (kV) against measured voltage (kV).

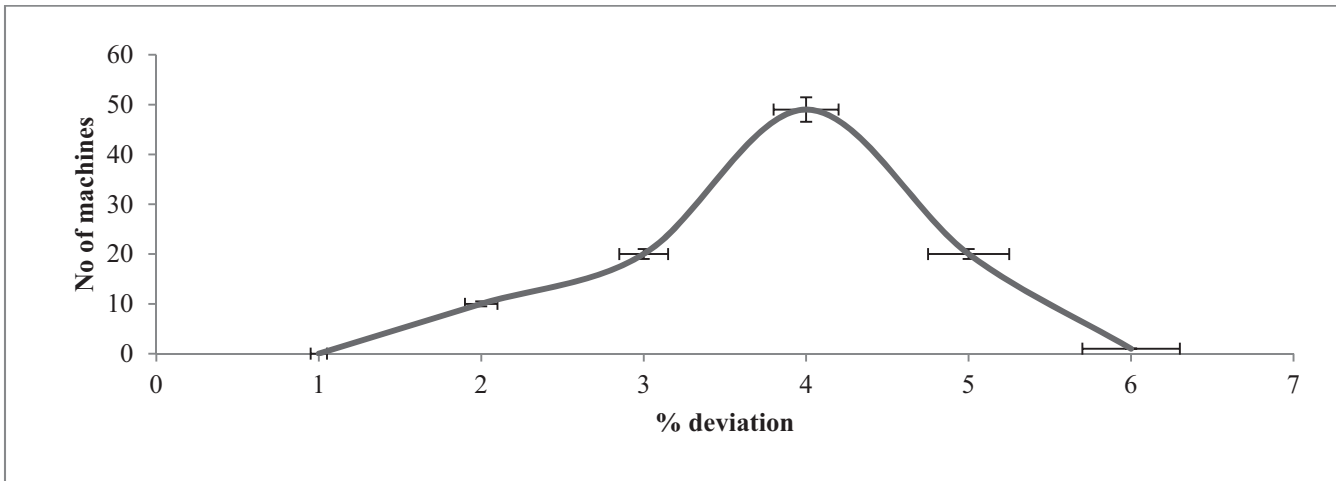
Fig. 2 A plot of no. of machines against deviation (%). Deviation less than 5% comply to MS 388.

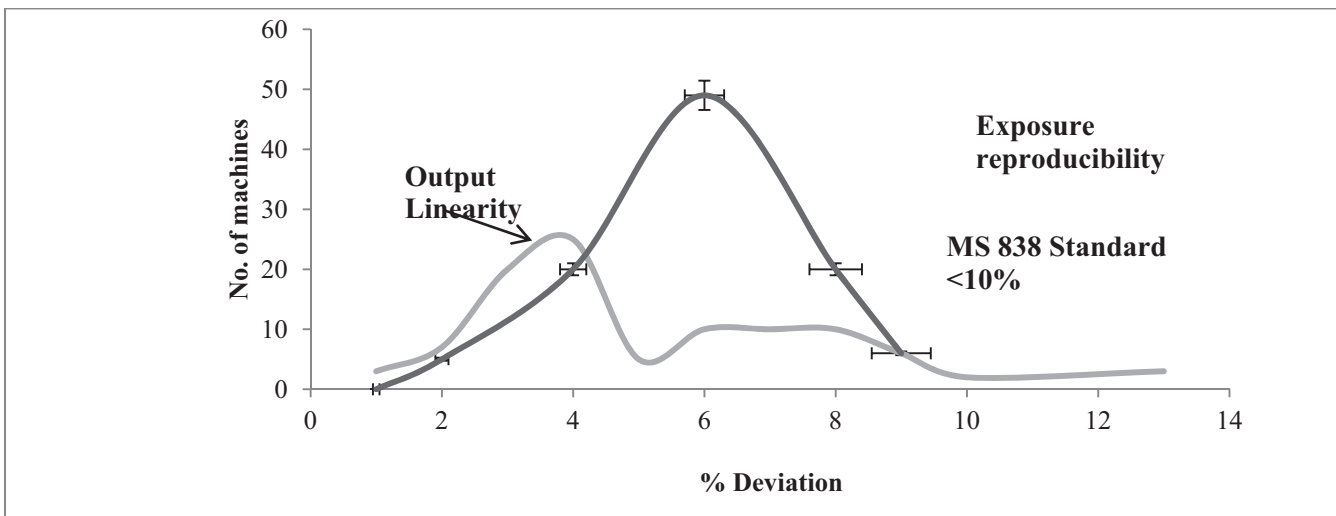
linearity out of MS 838 i.e. more than 10% deviation. Typical results of focal spot measurement are given in Table 2. Due to space limitation the results of other parameters measured such as exposure time, collimation, leakage and scattered radiation, and X-ray beam filtration are not shown. **Figure 4** gives the overall compliance of the machines tested.

Fig. 3 A plot of no. of machines having exposure reproducibility and output linearity that conforms to MS838.

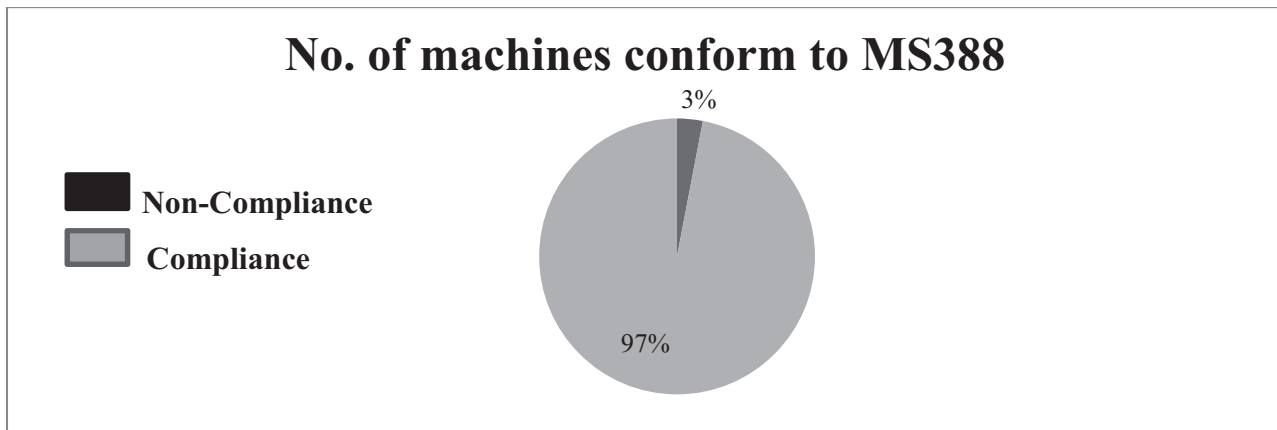
**Fig. 4** The overall number of machines that comply to MS 838. Total number of machines is 100.
