Recent Findings from Fukushima Daiichi Unit 1 Primary Containment Vessel Investigations

¹Tokyo Electric Power Company Holdings, Inc.

FDR2022, Fukushima J-Village

General information

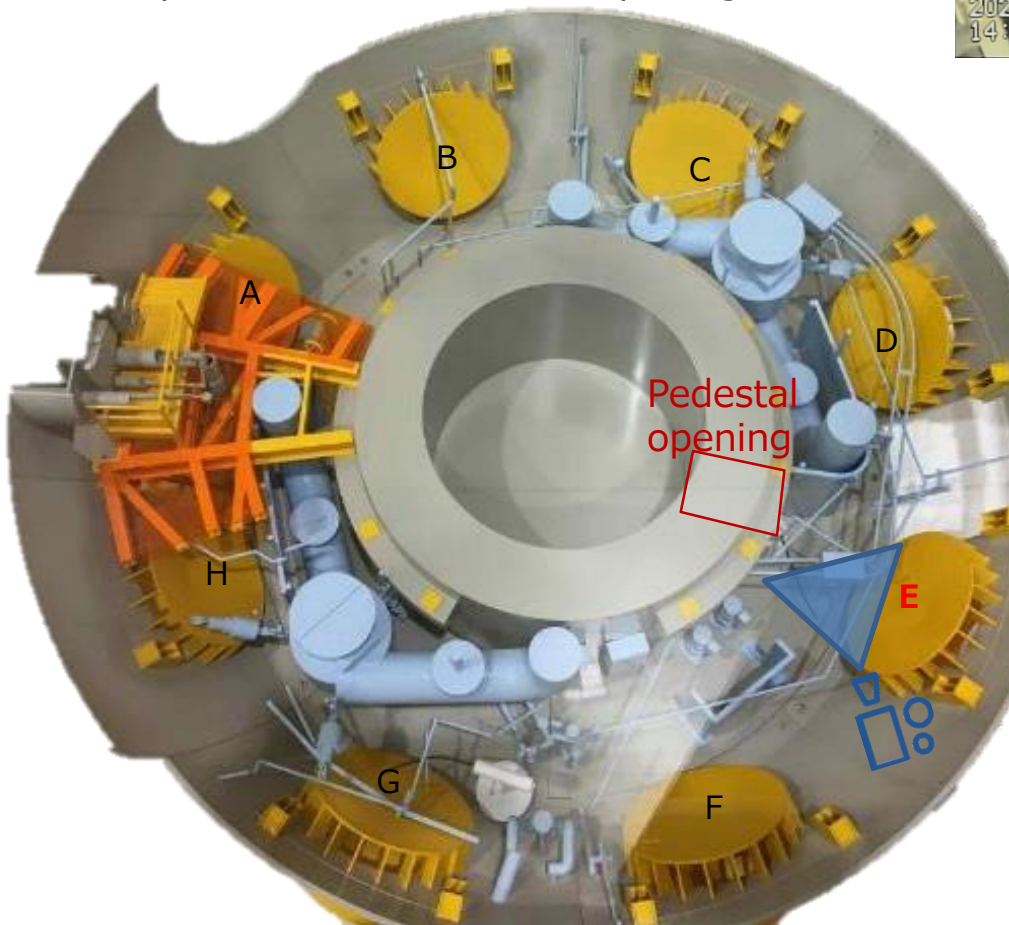
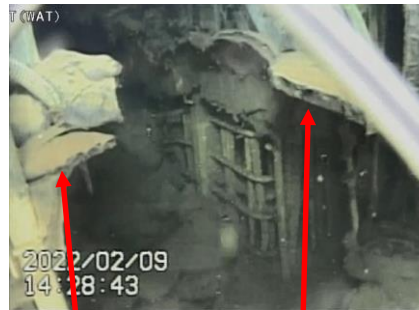
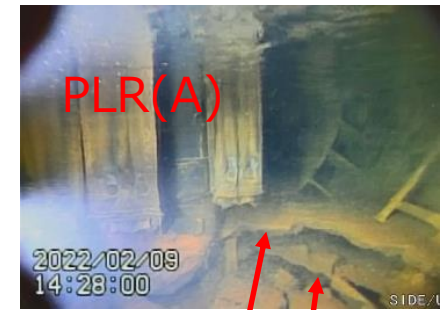
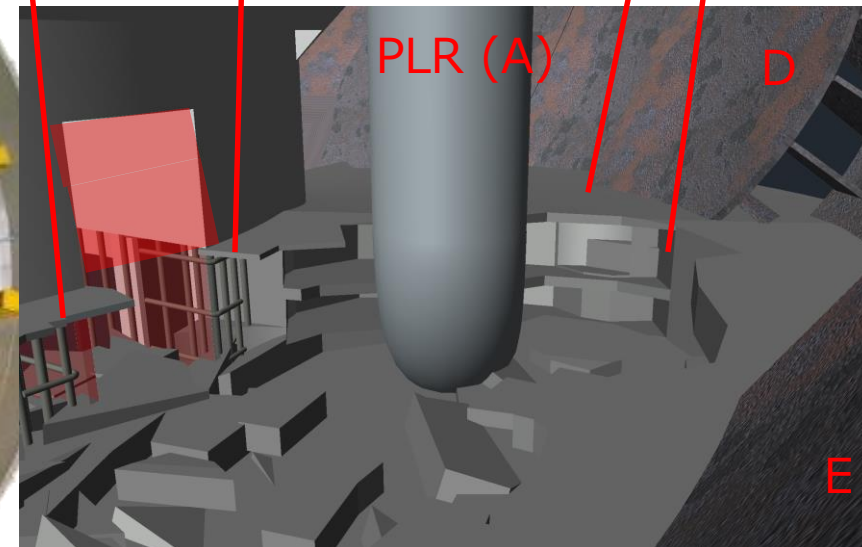
Image of state in front of the pedestal opening

- Deteriorated pedestal concrete exposing rebar
- Shelves attached to the pedestal concrete
- 2 layers of shelves attached to the D/W liner
- Collapsed shelves in front of opening

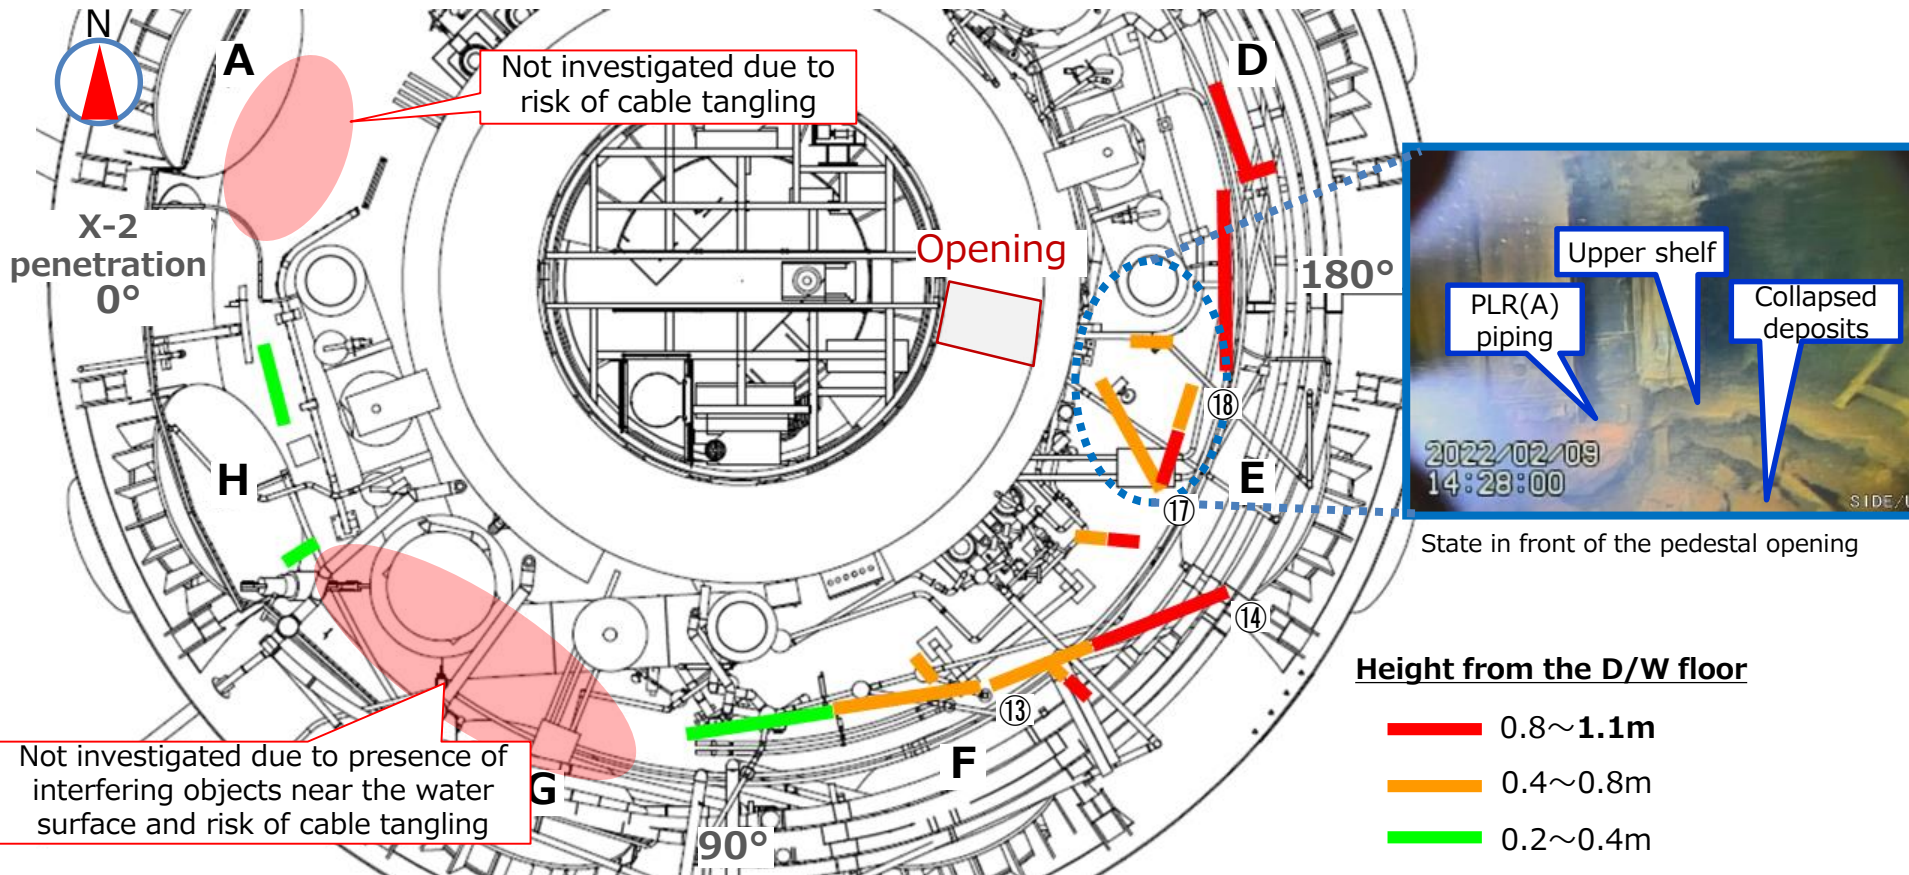
Results of the deposits height distribution investigation

- Generally decreasing height with increase of the distance from the pedestal opening
- **Maximum** evaluated height of **~1.1 m (outside of pedestal)**

Contrast with estimate of core and reactor internals piled only in the pedestal: ~ 1.1 m*

*rough estimate not considering equipment inside pedestal, sump pits and downwards progression of MCCI

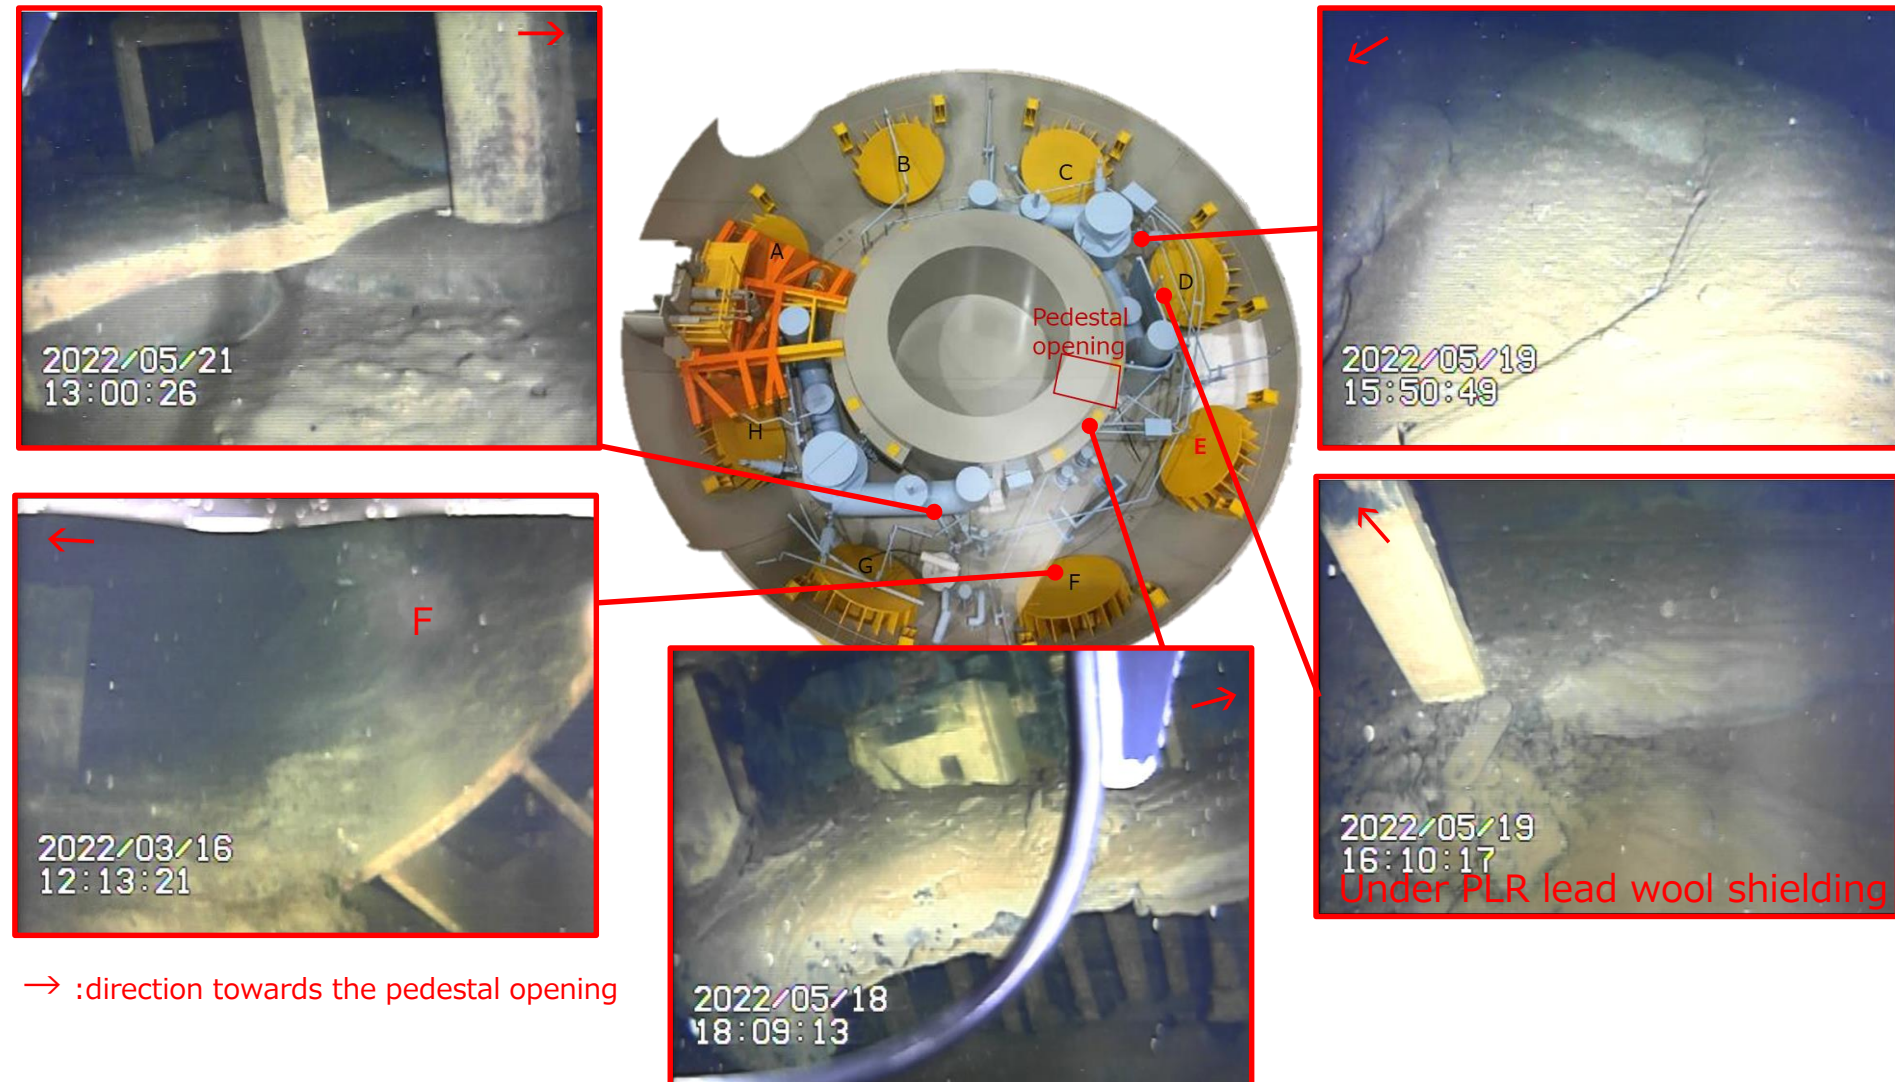
Distribution of deposits

- Deposits height increasing with distance from the pedestal opening in some areas
- Could some of them come from upper floors?

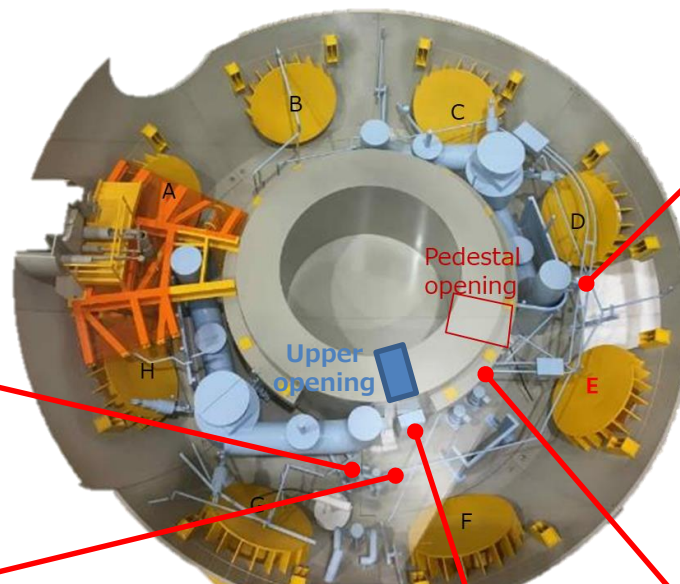
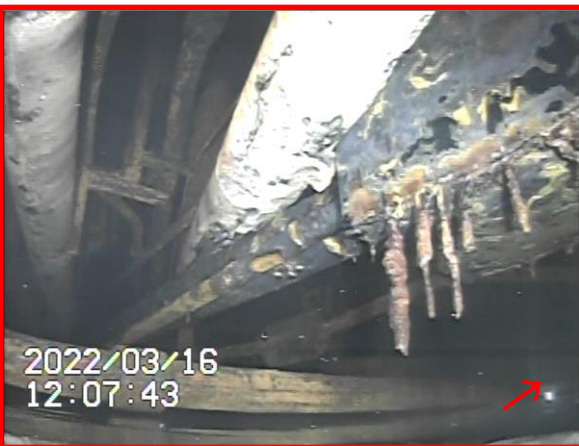
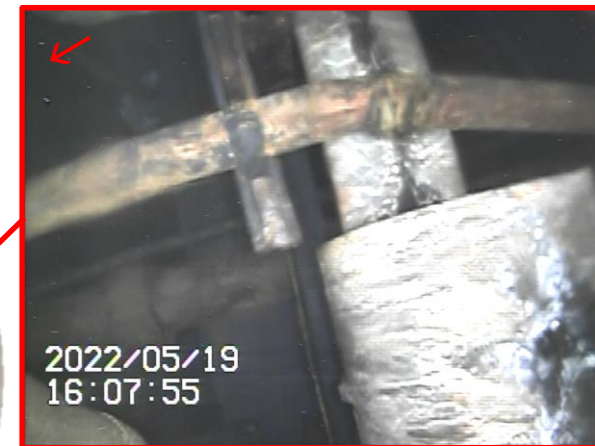
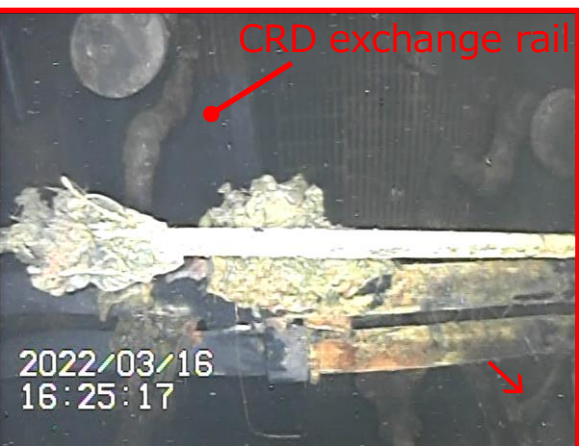
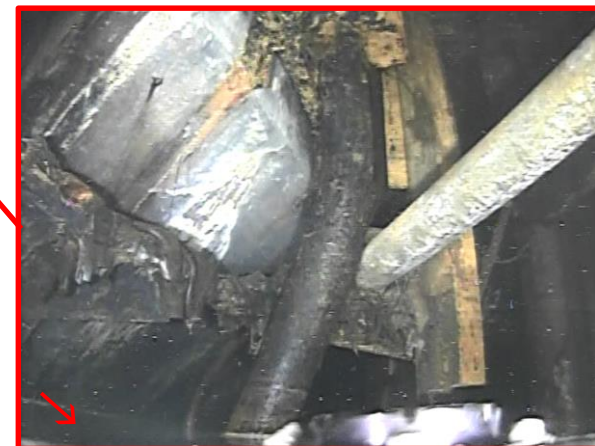
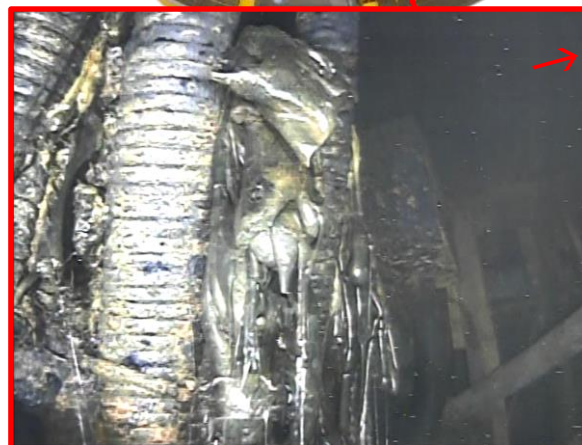
Deposits above water level

- Deposits hanging on pipes and supports
- Traces of solidified metal found on RCW and other piping

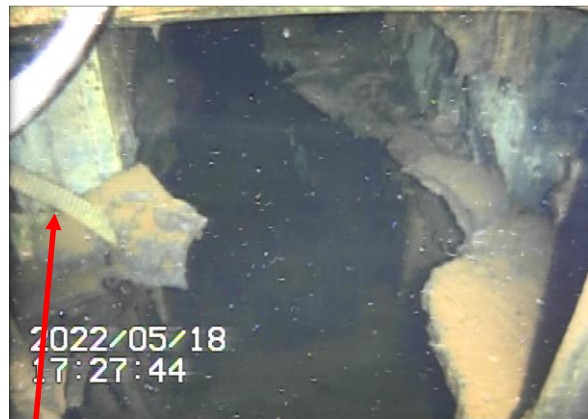
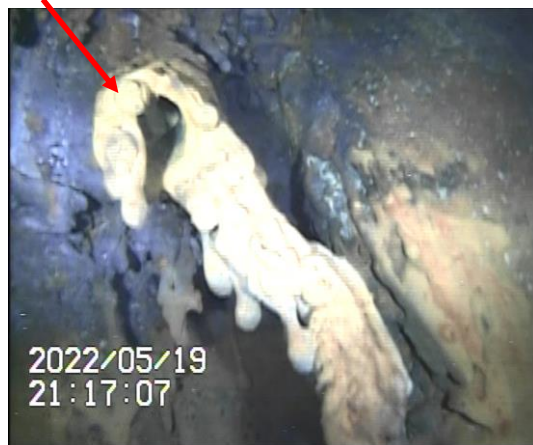
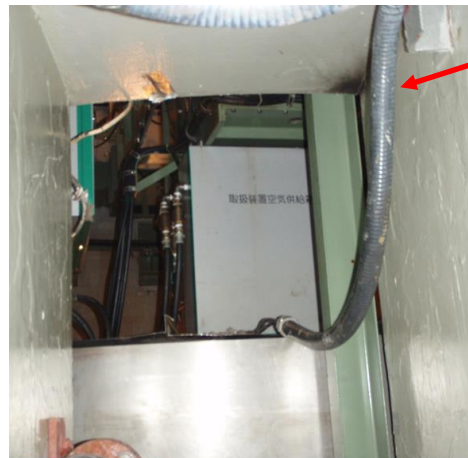
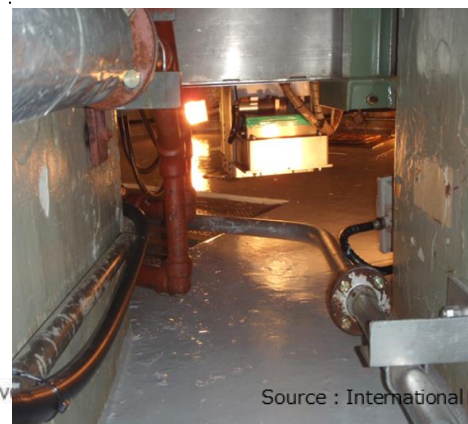
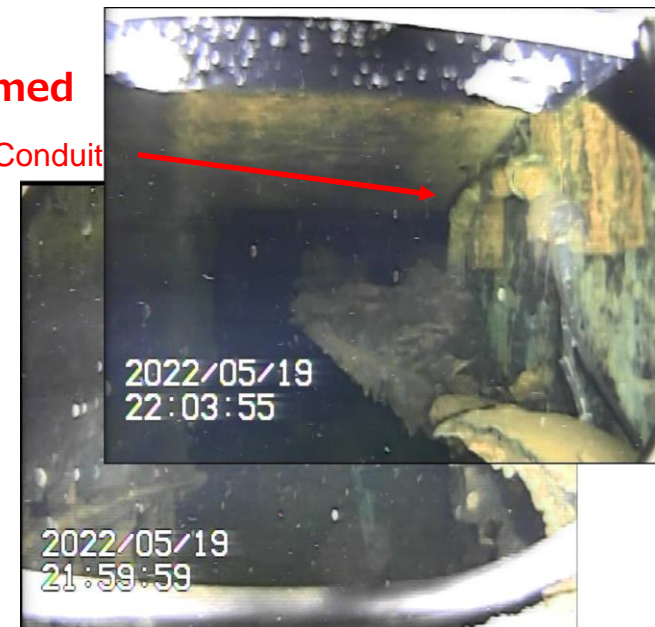
State of the pedestal opening

- No significant damage to the upper part of concrete
- Deposits shelves on the right side of the wall increasing in height towards pedestal
- “lavacicles” on bottom surface of the shelves

Free space existed below the shelves when “lavacicles” formed

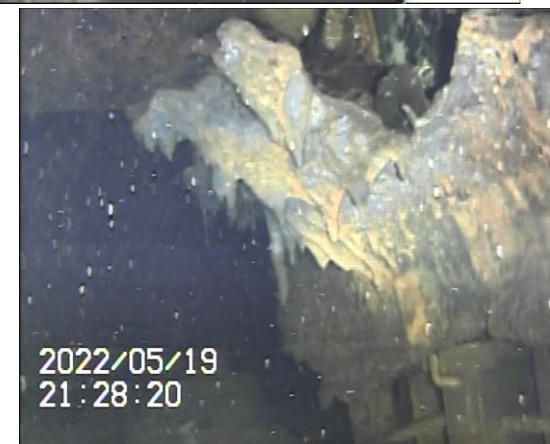
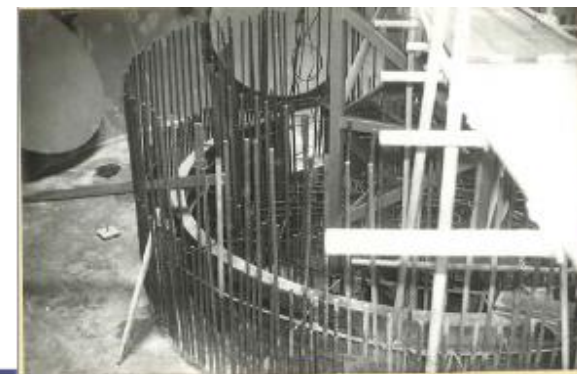
Pedestal concrete degradation below shelves

- Concrete degraded up to ~1 m from the floor
- No significant deformation of inner skirt
- Minor deformation of rebar (embossed pattern still visible)
- Height of the deposits in the pedestal ~1 m

Possibility of heat being transferred by inner skirt/rebar

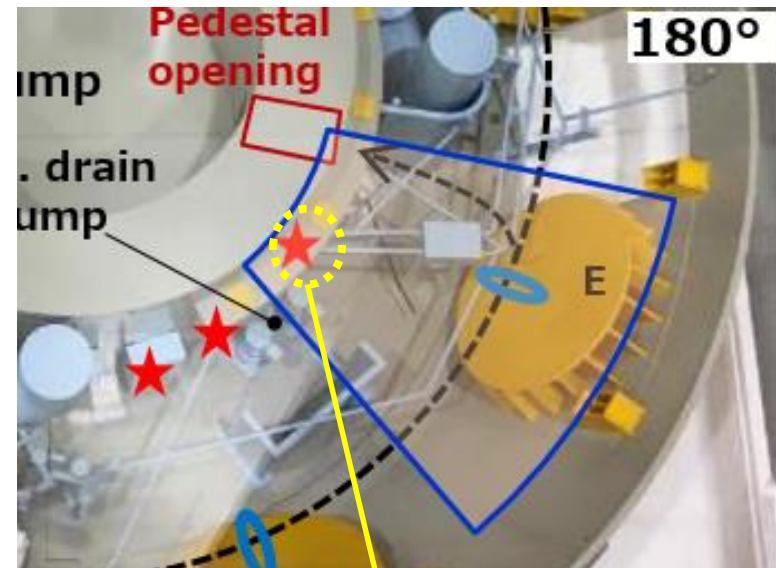
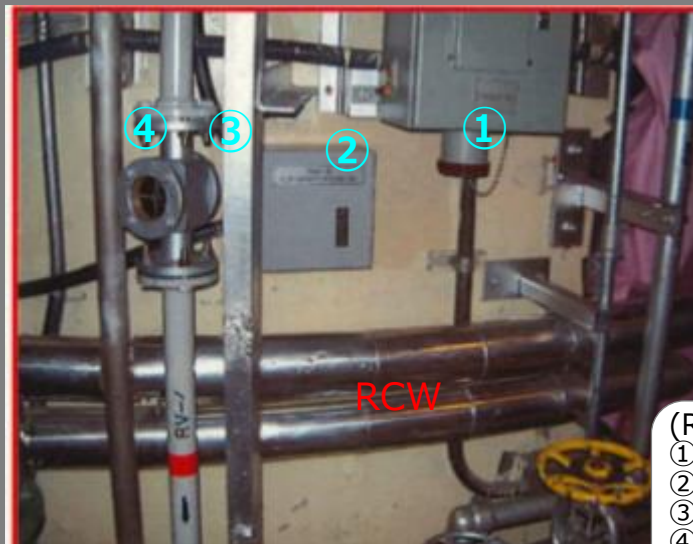
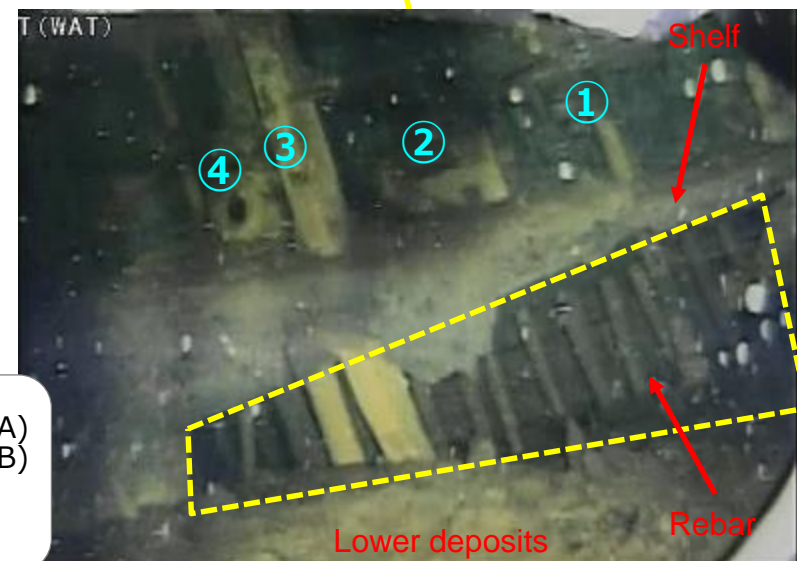
Pedestal concrete degradation below shelves

- Many metallic structures found to be relatively without deformations under the shelf
- RCW piping not found
- Rebar found without significant deformation

Low temperature concrete degradation?
Long term effects (coolant flow, etc.)?

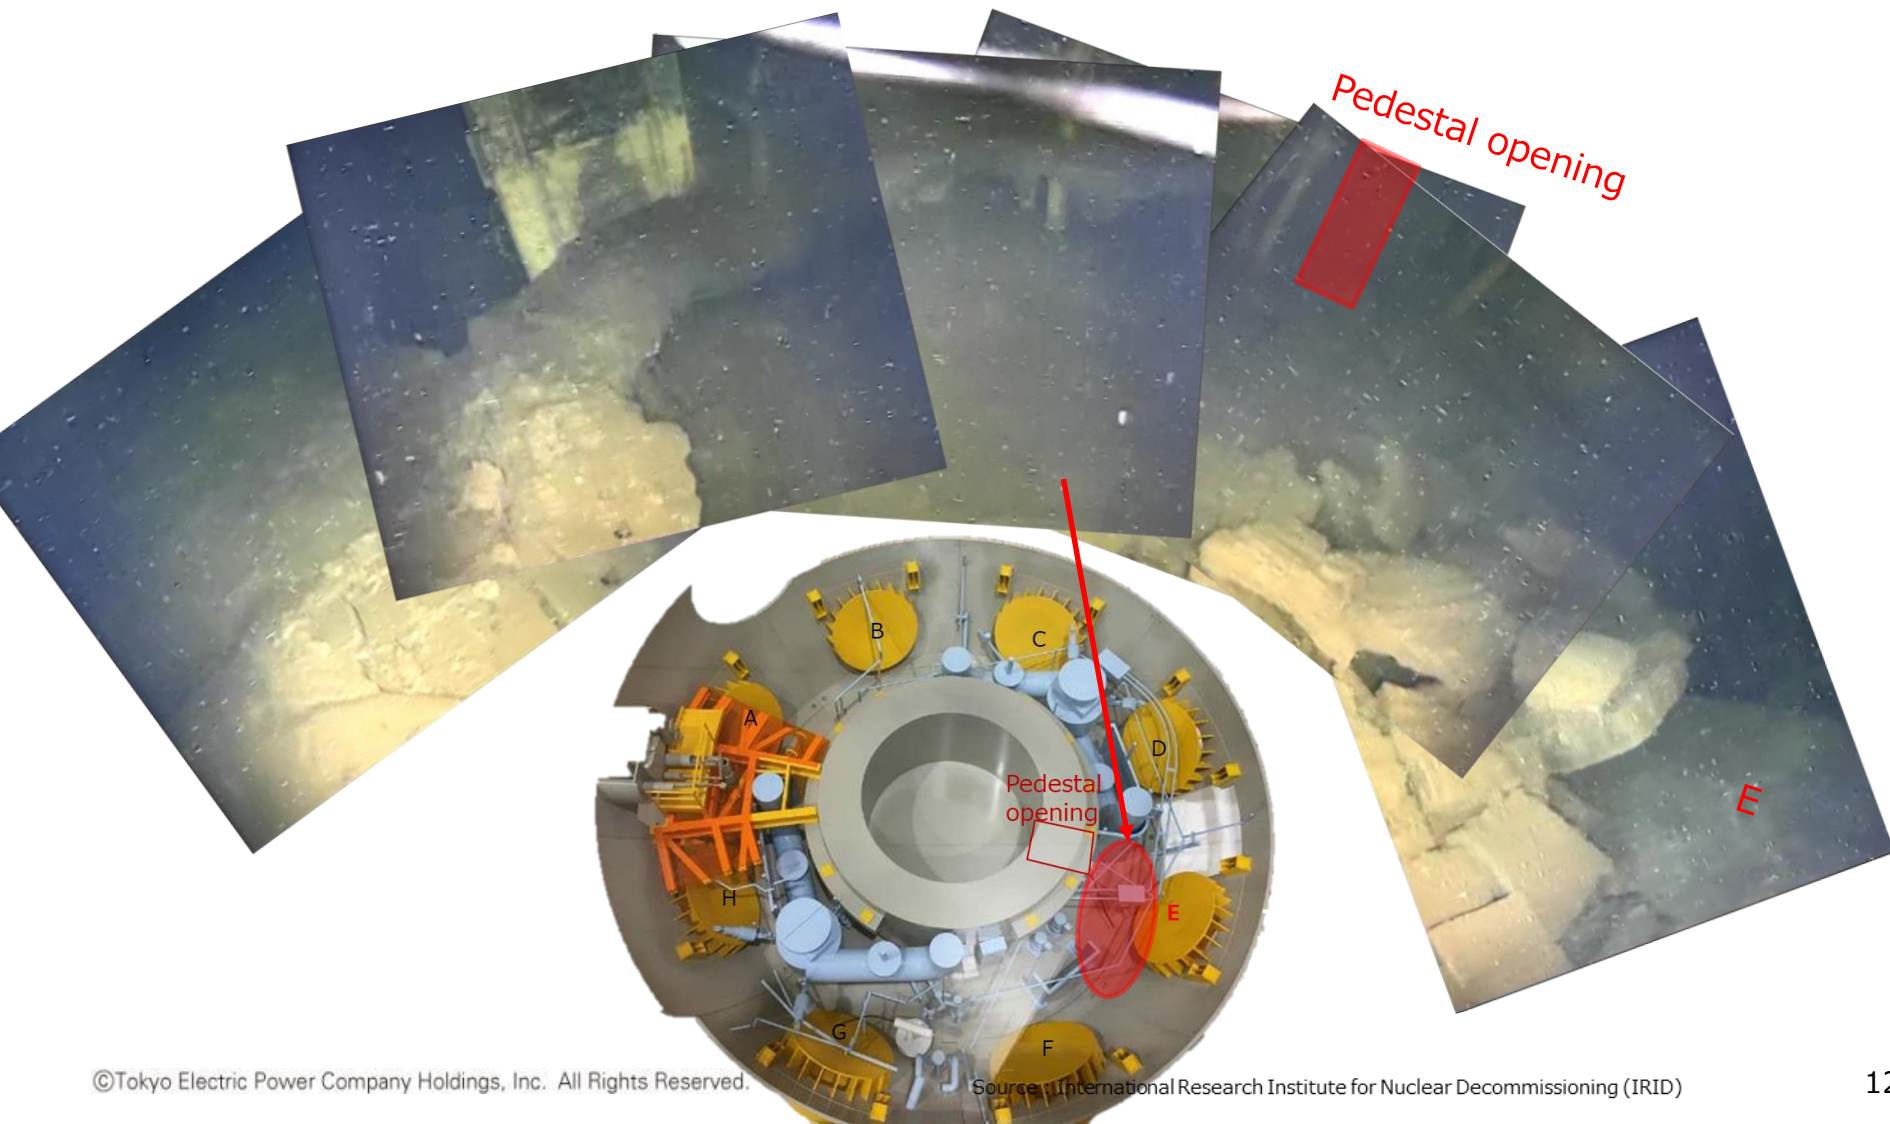
Formation of cavities and shelves

- Cavities found under the deposits
- Collapsed shelves found in higher amount near Jet Deflector E and PLR piping

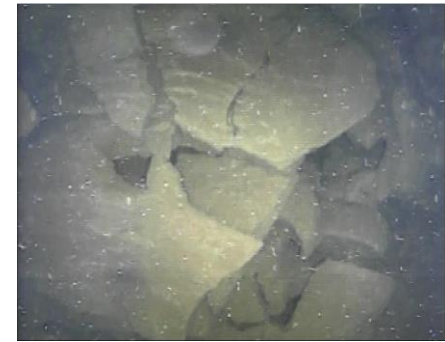
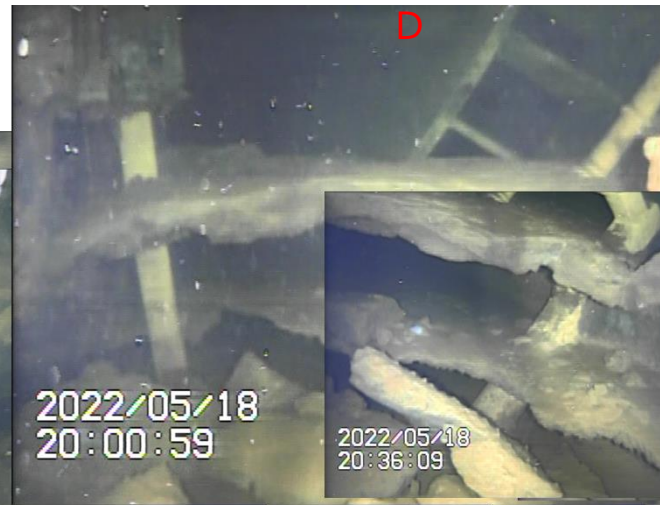
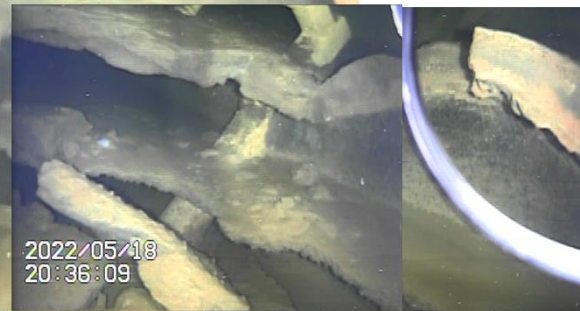
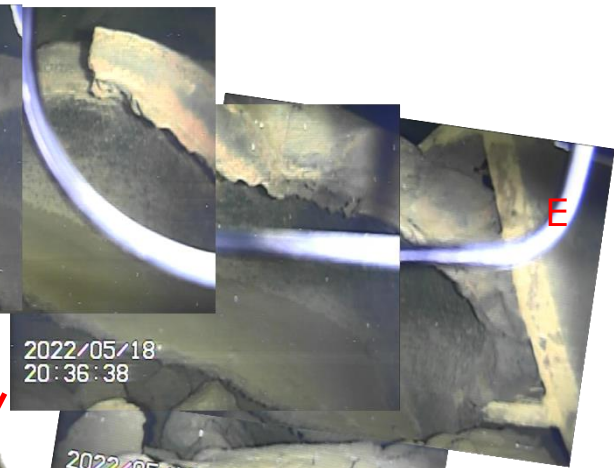
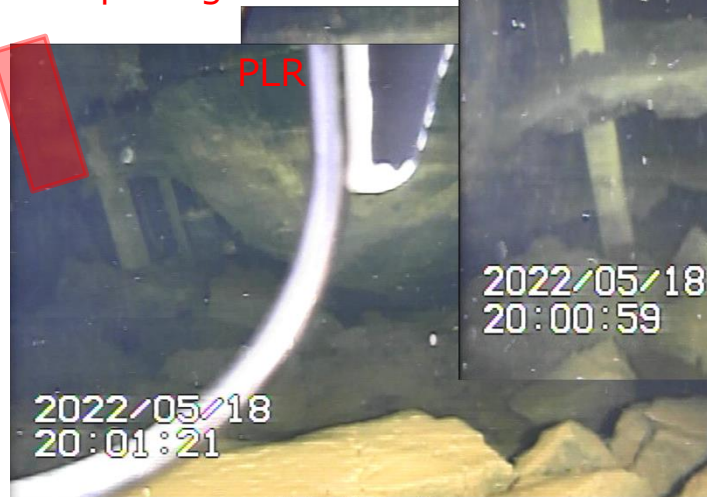
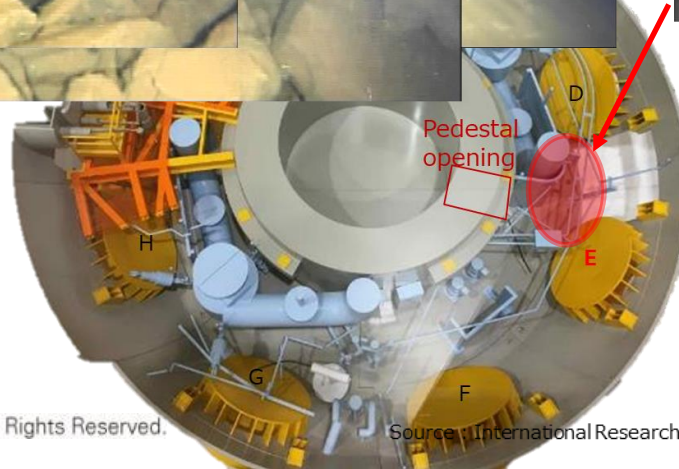
Formation of cavities and shelves

- Collapsed shelves seemingly forming one layer before
- Upper shelf coupled with the lower near liner
- No visible deformation of jet deflectors, PLR piping or support structures

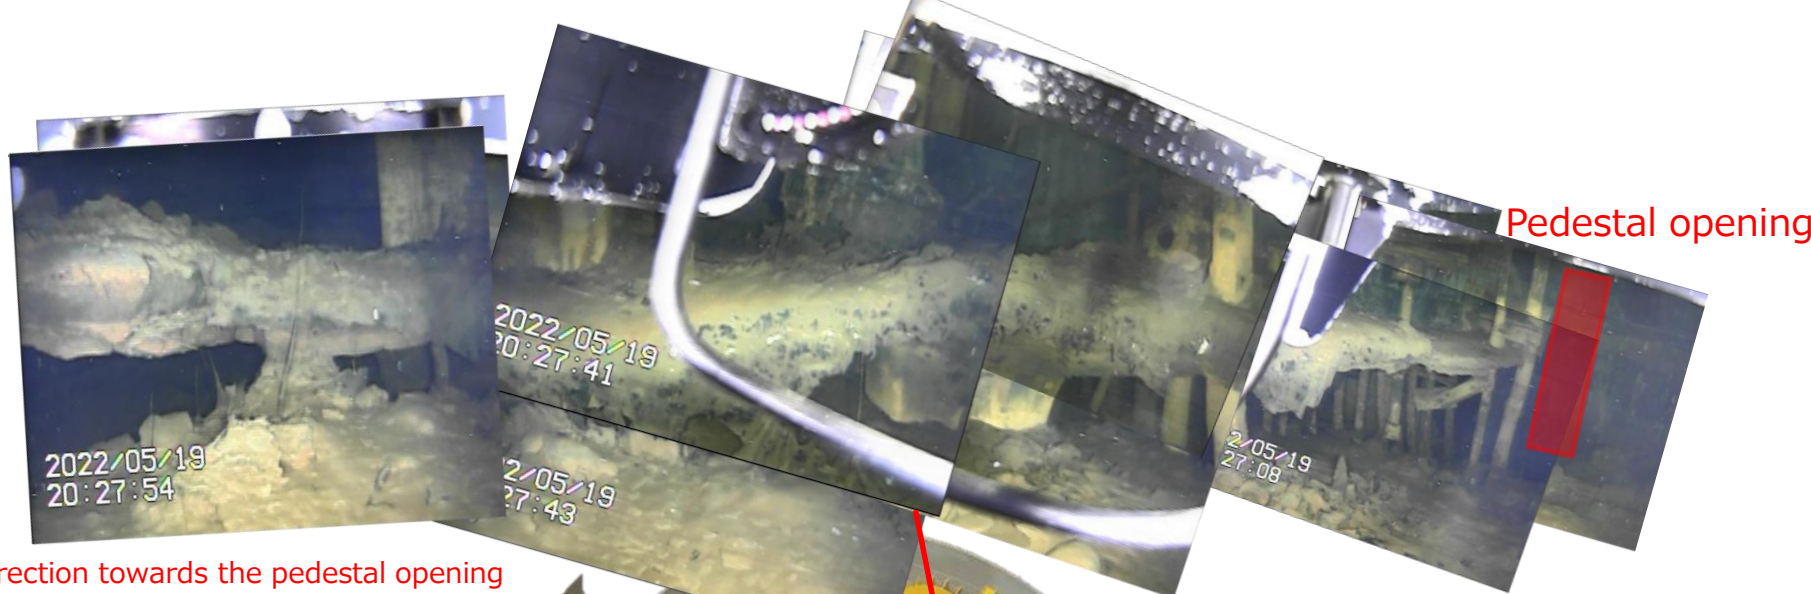
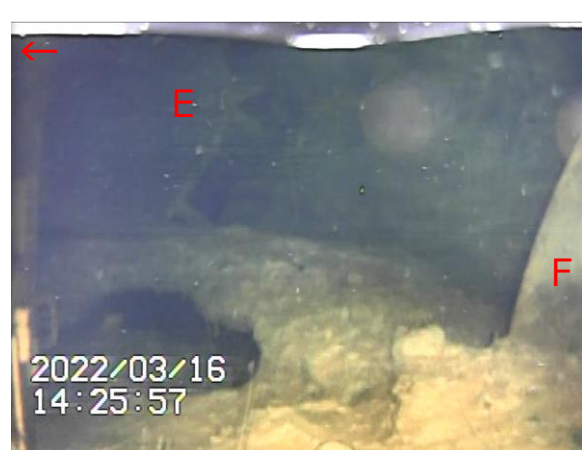
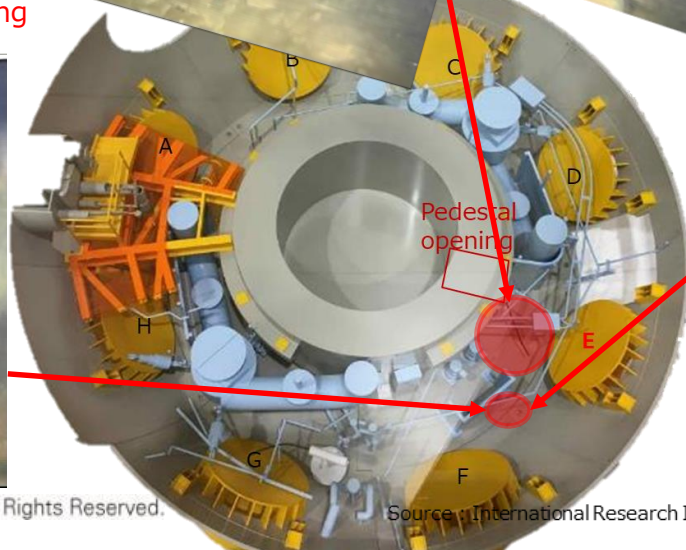
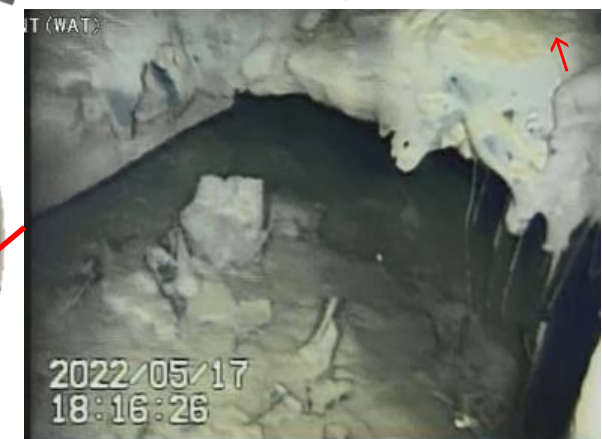
Formation of cavities and shelves

- Only one shelf with deposits piled from above
- Collapsed shelves not found in big amounts

Different in nature than shelves near PLR and Jet Deflector E or buried in other materials?
