ARTICLE

Characterization of the VULCANO test products for fuel debris removal from the Fukushima Daiichi Nuclear Power Plant

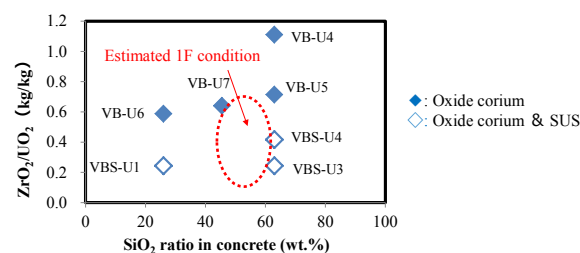
Characteristics of the MCCI product depends on initial corium and concrete composition since the MCCI product is composed of corium and concrete components. Initial test conditions of past VULCANO test campaigns were compared with that of the 1F as shown in **Figure 1**. Several VULCANO MCCI tests have similar conditions to 1F1.

Figure 1. Initial corium and concrete compositions of past VULCANO test campaigns.

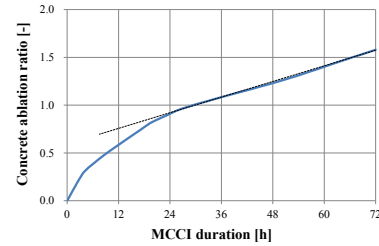
The calculated concrete ablation volume ratio is shown in **Figure 2**. The ablation volume ratio increases rapidly at the beginning of MCCI, and then the slope

becomes constant. One reason for this tendency is the decrease of molten pool temperature. The liquidus temperature of the molten pool composed of corium components decreases due to the mix of ablated concrete component. Subsequently, the molten pool temperature and concrete ablation rate decrease. Another reason for this phenomenon is the surplus heat derived from the gap between the input molten core temperature and the initial molten pool temperature which is slightly higher than the melting temperature. The surplus heat is distributed during initial 2.8 hrs. The calculated value of $\Delta V/V$ after 72 hrs was 1.58.

Figure 2. Calculated concrete ablation volume.

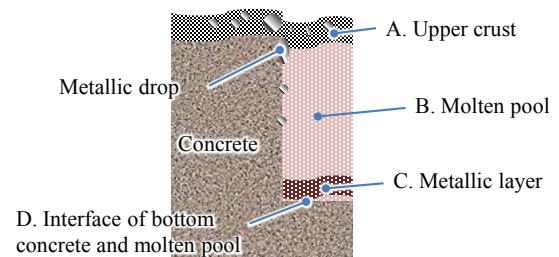
Figure 3 presents an image of cross-sectional view of the VBS-U4 test section, as observed during the dismantling. In this test, four samples are chosen as representative of different locations. The approximate locations of four samples are shown in **Figure 3**.

Figure 3. A cross-sectional view of the test section.

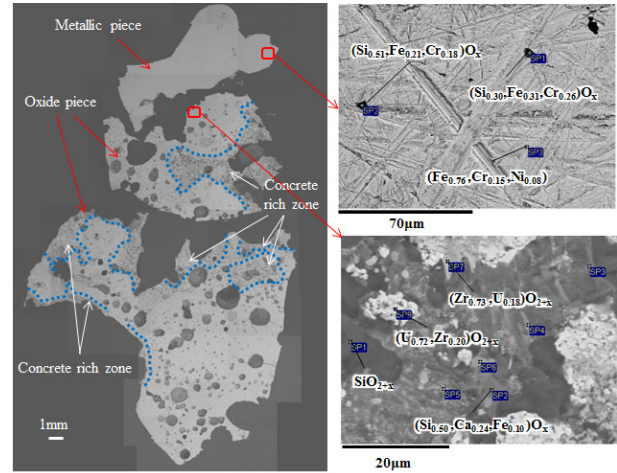
Sample A is composed of three pieces as shown in **Figure 4**. The upper segment is metallic and other two segments are oxide. At the edges of the oxide segment, narrow concrete rich zones, indicated with blue dash lines, can be observed. Bubbles, which are confirmed as dark holes on the micrograph are present in both oxide segments, with sizes varying from $\sim 10 \mu\text{m}$ up to 2.1 mm.

The microstructure of the edge of the metallic segments and the oxide segment at the micrometer scale is shown in **Figure 4**. The heterogeneous structure composed of several oxide phases derived from corium or concrete components is confirmed in the oxide segment. These phases would separately solidify in the liquidus corium rich nodule.

Figure 4. Microstructure of sample A.

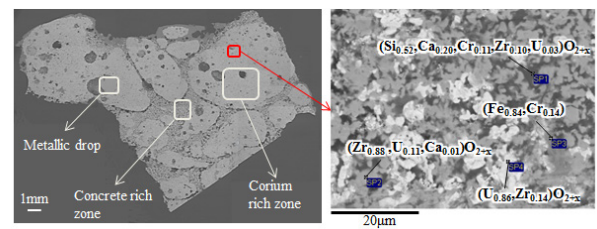
The microstructure of sample B is shown in **Figure 5**. It can be confirmed that the corium rich region, which has a diameter of 1–20 mm, is surrounded by concrete rich region at the millimeter scale. This shows a higher liquidus temperature of the corium rich region than concrete rich region and convection phenomena in molten pool during MCCI. Moreover, the heterogeneous

microstructure composed of fcc-(U,Zr)O₂, SiO₂, Fe-Cr, in corium rich region are confirmed at the micrometer scale. SUS was partially oxidized, and Cr formed Cr₂O₃. SiO₂ forms amorphous and some crystalline phases, and it exhibits differences of localized cooling rate in the molten pool.

Figure 5. Microstructure of sample B.

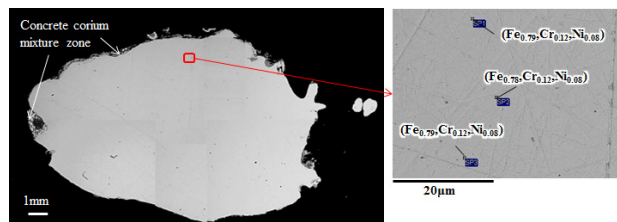
A general view of the sample C at the millimeter scale is given in **Figure 6**. Sample C is a homogeneous and dense metallic block with small corium concrete mixture zones at its edges. The microstructure at the micrometer scale is also homogeneous and composed of α -Fe containing Cr and Ni. Cr is partially oxidized and the composition ratio is nearly constant in different locations. It shows that the oxidation reaction by concrete decomposition gases is a dominant reaction in this region and that the interaction with oxide corium phases would be small.

Figure 6. Microstructure of sample C.

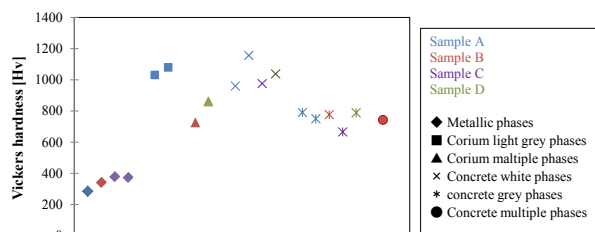
Vickers hardness of 10–50 points, with respect to different phases, was measured in each sample. The average values of each phase are shown in **Figure 8**. The differences between the samples were minimal. In addition, the value of Vickers hardness between the same phases is similar. Vickers hardness of the metallic phase is relatively low and that of concrete rich phase is distributed to wide range. U or Zr rich phases and the concrete pure phase are relatively hard.

Figure 8. Vickers hardness of the samples.
