# Analysis of metallic sim-debris of the bundle degradation tests

Presentation at the 2021 AESJ Fall meeting

# Mock-up of BWR assembly after CLADS-MADE-02 test

# Post-test control blade debris characterization

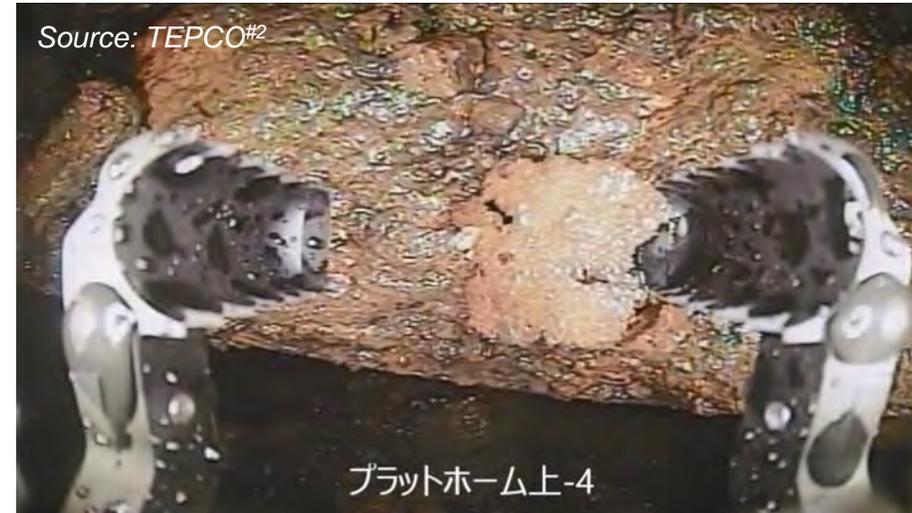
Decommissioning preparation in Unit 2:  
*Pedestal debris inspection Feb. 2019*

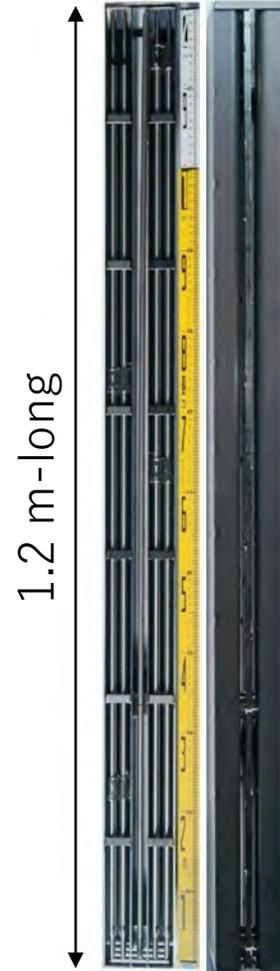
1.2 m-long

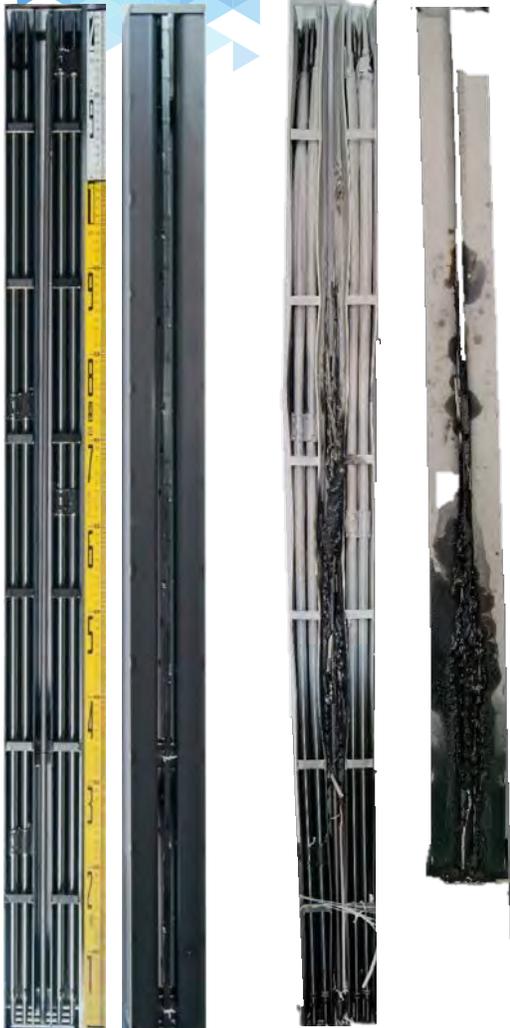
before

after

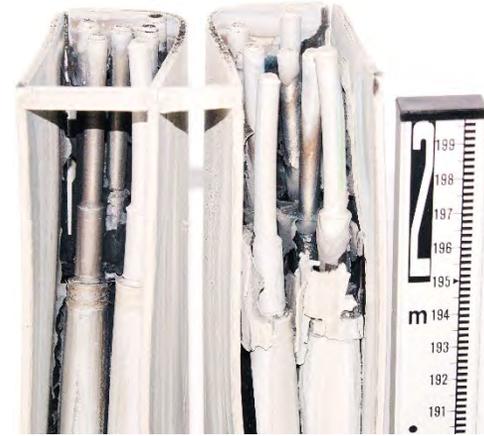
Only oxidized  
 $T > 1500 \text{ }^\circ\text{C}$

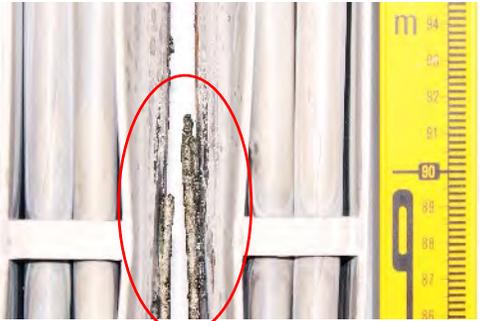
Remaining control rod  
 $1400 < T < 1500 \text{ }^\circ\text{C}$

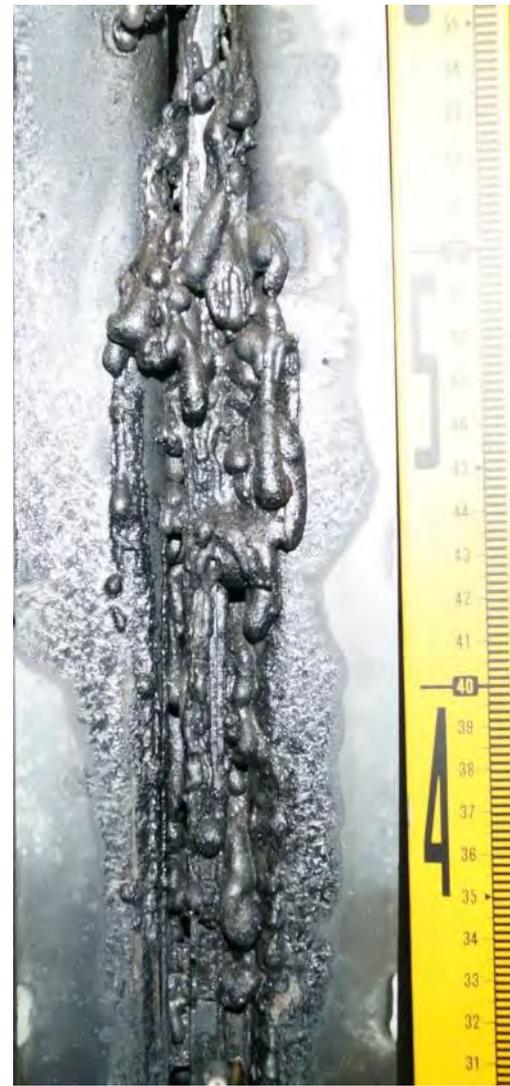
Solidified melt in the  
 $\approx 1200 < T < 1400 \text{ }^\circ\text{C}$

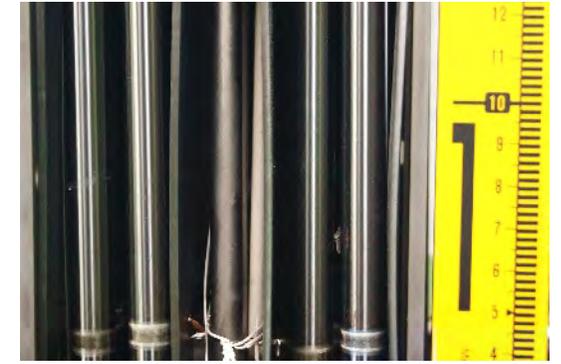
Lower part Slight oxidation  
 $T < 1174 \text{ }^\circ\text{C}$

Sample Support  
 $T < 1000 \text{ }^\circ\text{C}$

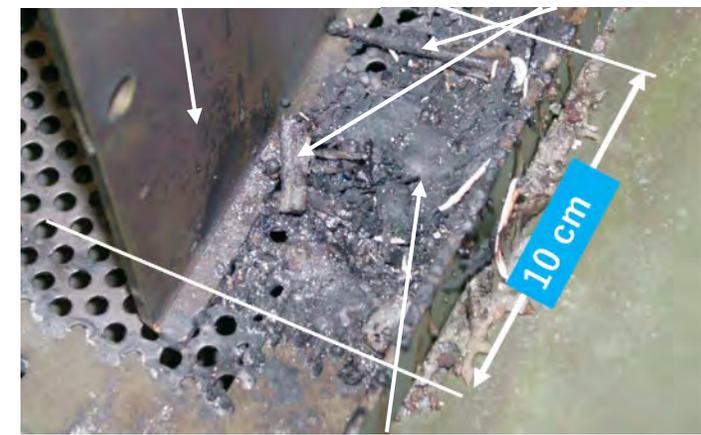
Damaged control blade parts

A 10 mm-thick pile of the control blade melt

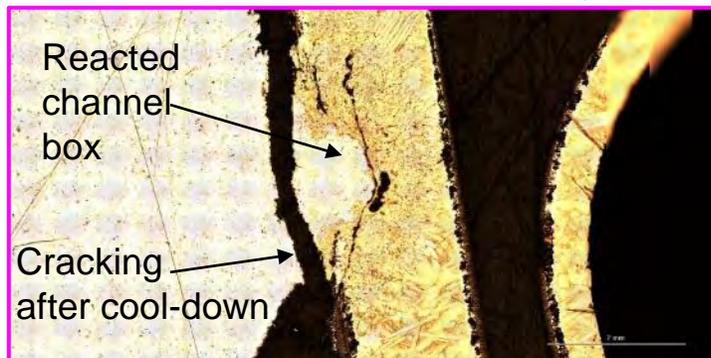
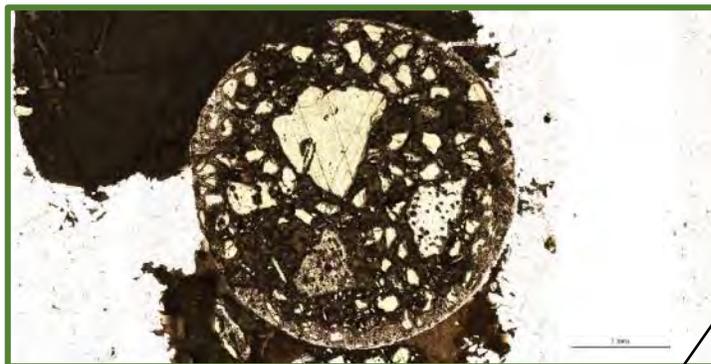
## Optical microscopy

Channel box  
(Zircaloy-4)

Ex-tubes  
with B<sub>4</sub>C  
now melted

control blade covered by melt

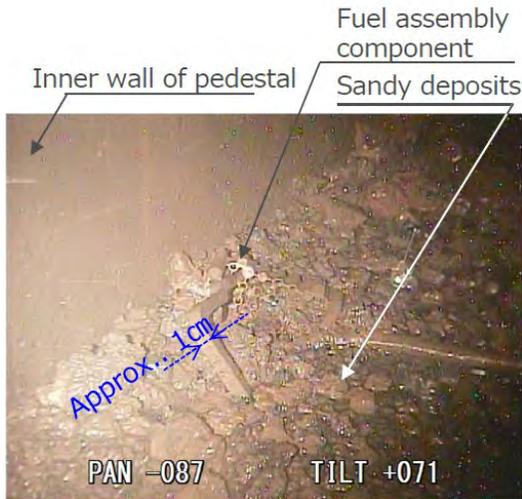
<b>Type I. Solidified melt (metallic)</b>	
<b>Type I. Stone-like melt agglomerates (metallic)</b>	
<b>Type II. Zr oxidized debris (oxidic)</b>	
<b>Type III. Partially melted original parts (metallic)</b>

- Comparison of the sim-debris and the TEPCO HD 1F Unit 2 PCV investigation data showed many similarities between the outer appearance of the sim and the real debris, which is promising for study of the real debris formation mechanisms by using sim-tests
