Fukushima 1st NPPs Accidents and Disaster Caused by the Pacific Coast Tsunami of Tohoku Earthquake

–Lessons from Evaluation of the Fukushima 1st NPPs Accidents–

Hokkaido University, **Tadashi Narabayashi and Kenichiro Sugiyama**

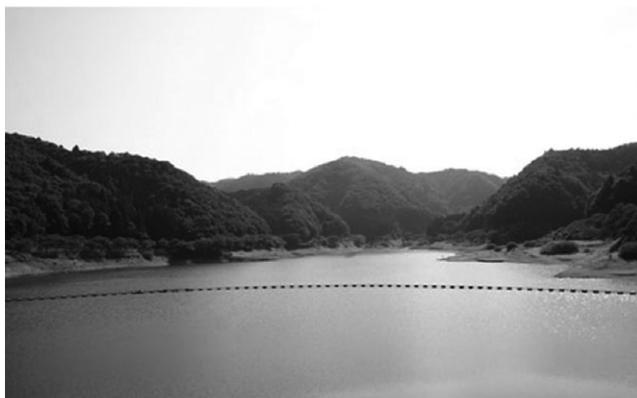
Figure 4 Sakashita Dam (Capacity 2.84 million ton)⁵⁾

Although the condensed water storage tank or the excess water of the waste processing tank was considered as the supply source of freshwater, most of the freshwater was injected into the reactor core. Meanwhile, there is 2.84 million tons of water in Sakashita Dam⁵⁾, as shown in **Figure 4**, which was constructed during the construction of Daiichi Power Station to be used as a water source in the power station. Since there was a fresh water supply pipe from the dam to the sedimentation tank inside the power station premises, using this water was considered to be the most effective. However, the piping was damaged by the earthquake and repaired by the Self Defense Force. This water from the dam became usable only after more than 10 days since the start of seawater injection. During this time, securing freshwater was constantly an important issue; for example, the barges of the U.S. Army filled with freshwater came forward to provide water as help measures.

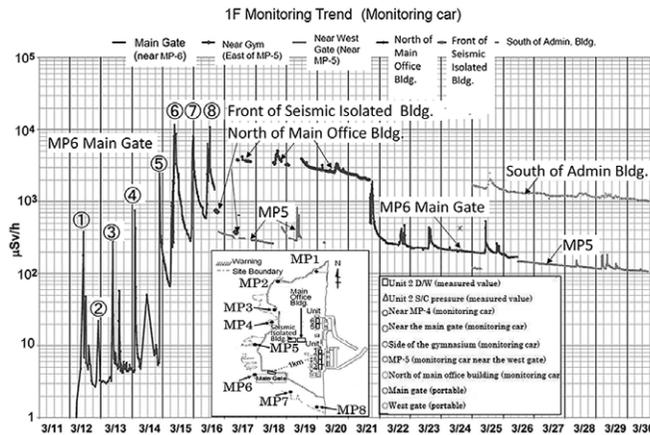
Figure 12 Radiation dose in the air dose rate in the Fukushima Daiichi NPS site²⁾

12 (Figure 11). At 6:00, the PCV pressure decreased to 650 kPa. This means the leakage of vapor mixed with fission products (FPs) through top flange of PCV started. Indeed, the radiation level in the power station site started to increase, as shown in **Figure 12**. Moreover, the hydrogen from the zirconium water reaction was mixed in the steam. The hydrogen rose to the top floor in the R/B, where the shield plug, at the center of the operation floor, leaks the hydrogen through the gap around the circumference of the shield plug (about 20 mm), and started to accumulate in the operation floor.

The seawater hose was manually installed down to the beach by going through the debris brought by the tsunami, which attached radioactive materials. It was considered as a difficult task, considering the emergency evacuation after the hydrogen explosion, among other things. In any case, following order from the Prime Minister's office, seawater injection using the CS line connected the fire pump started at 20:20. Following this seawater injection, steam was generated from the partially melted core and the radiation dose in the air increased again, as shown in Figure 12②.

the NPS site, which reached its peak 5 shown in Figure 12. On the next morning at 6:14, the pressure in PCV decreased at once to atmospheric pressure, together with the sound of explosion near the S/C was reported. At 9:00 on March 15, white steam appeared from the blowout panel and the radiation dose level reached the peak of 10,000 $\mu\text{Sv/h}$ shown in Figure 12⑥, and a large quantity of volatile FPs was released into the atmosphere.

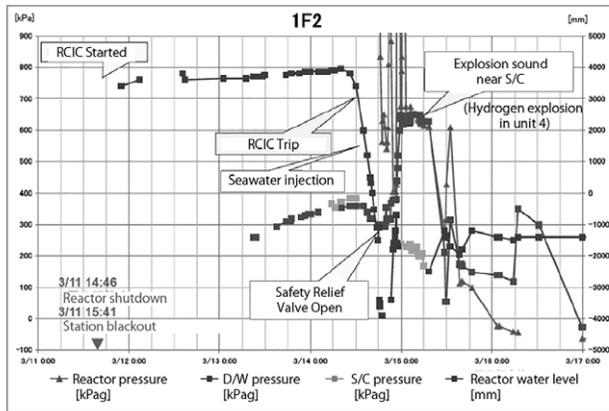
Figure 14 Time transition of Unit 2 after the accident ¹⁾

As shown in **Figure 14**, at Unit 2, the steam turbine-driven RCIC continued its operation even after tsunami and water injection continued until around 11:00 on March 14. However, after RCIC stopped working, the water level in the reactor decreased rapidly. Seawater injection started at 16:34. However, they did not notice that the fuel of the firefighting pump was empty. During this time, the water level decreased to the bottom of active core (BAF) and fuel rod was completely exposed. When the seawater injection restarted again, high-temperature fuel rod reacted with water and significant amount of hydrogen mixed with steam was blown out into the S/P. At this time, the pressure in PCV started to increase rapidly due to steam and hydrogen. The dry vent was conducted before 24:00 on March 14 but it was failed by the loss of air of vent valve. This was accompanied by an increase in the radiation dose in

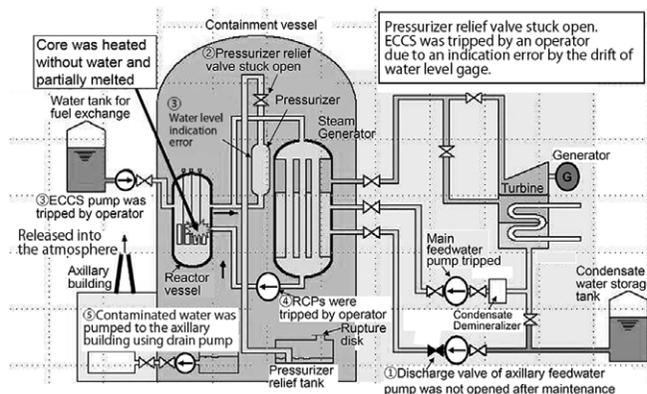
Figure 18 Accident at Unit 2 of Three Mile Island¹²⁾ in the U.S.

At the predawn on March 28, 1979, there was an accident at Unit 2 (power output 960 MW) of Three Mile Island NPS (TMI) located in Pennsylvania in the U.S., which caused a severe damage to the reactor core. The reactor of the TMI Nuclear Power Station was PWR (made by Babcock & Wilcox). Its characteristics were small water volume in a steam generator (SG) and SG generate superheated steam. Following is its explanation with reference to **Figure 18**¹²⁾.

The accident occurred when the main feedwater pump, which supplied water from the condenser to SG, tripped. The axial feedwater pump immediately started automatically at a rated speed after 30 s. However, the two discharge valves for the pump were closed; therefore, the water was not supplied to the SG. At this time, a sign plate that says “keep closed” was on the valve control switch in the control room. This should have been changed to “open” after the maintenance but they did not notice it during the patrol. It was already 8 min since the accident when an operator noticed it and opened the valves. At the reactor, the temperature and pressure of the primary system rose because water was not flowing to the SG, the pressure relief valve on the upper part of the pressurizer opened automatically, and the control rod was inserted to the core. The reactor shut down as it was designed to do so. However, the pressure relief valve did not close automatically; it was stuck open due to the damage on the pilot valve and could not be closed again, and caused the loss of coolant for the primary system and the pressure to become too low. This signal triggered the ECCS to start automatically, which started injecting the cooling water into reactor vessel. However, the operator stopped the valve of one system 4 min after the accident and after 10 min, the valve of the other ECCS

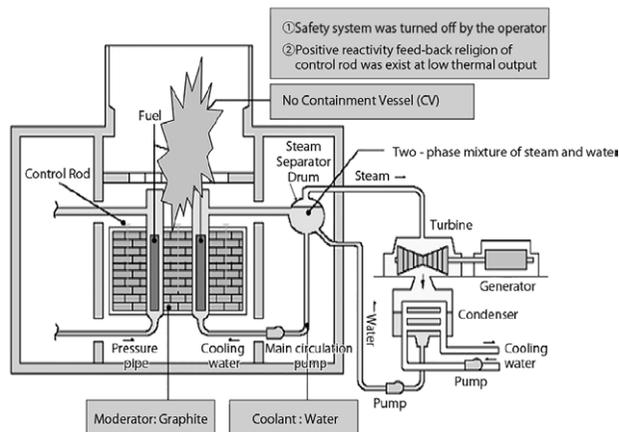
Figure 19 Factors of Chernobyl Nuclear Power Station Accident ¹²⁾

As shown in **Figure 19** ¹²⁾, this reactor was a light water-cooled graphite moderated reactor (RBMK-type) developed in the former Soviet Union. The reactor core consists of a large piece of graphite with many vertically placed thick pressure pipes (1700 pipes). The fuel assembly is inserted into each pipe. Cooling water is run through them to heat/boil it and generates steam. This steam is separated from water in a steam-water separator (steam drum), which is then collected and sent to the turbine. This reactor is a thermal neutron reactor, and therefore, requires a neutron moderator, for which graphite is used. The light water flowing around the fuel in the pressure pipes mostly plays the role of heat transportation. When a core is designed with the concept of “graphite for moderation, light water for cooling,” as in this reactor, there is a possibility of positive feedback due to the void generated during low output, unlike the light-water reactor system with the concept of “light water for both moderation and cooling” that is used in the power generation in Japan.

this, despite the regulation (operation procedure) that forbade normal operation with less than 20% output, operators tried to recover the output by removing the safety device and pulling out many control rods. As a result, void was generated, accompanied by the reactor core instability at approximately 7% output, leading to the loss of control. As it has characteristic to temporally increase the output when the control rod is inserted in this situation, the nuclear fission energy reached 300 GW, which is about 100 times the rated output, in a few seconds after pressing the scram button, causing the nuclear runaway.

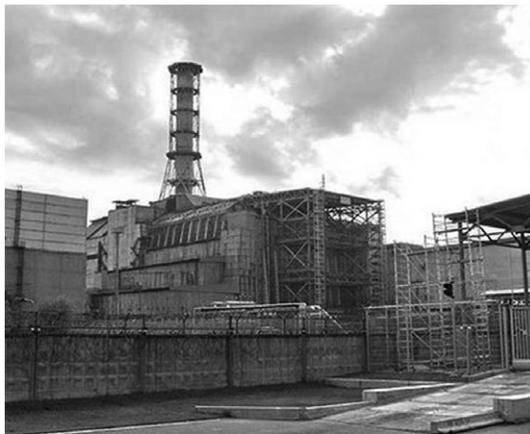
Figure 20 Chernobyl Nuclear Power Station after 25 years¹⁵⁾

Figure 20 shows the possibility of radioactive materials leaking from the decrepit stone

coffin of Chernobyl Power Station after 25 years. However, the dose has been lowered to the point where sightseeing tour is possible. Based on the information of the contaminated areas within 400 km radius from the Chernobyl Power Station, Fukushima 25 years from now is predicted to have low contamination within 40 km radius. Moreover, we wish for a recovery to better future through measures such as soil exchange of schoolyards with high contamination level or active cultivation of plants that store radioactive cesium in their stalks or roots.
