Recent Findings from Fukushima Daiichi Unit 1 Primary Containment Vessel Investigations

¹Tokyo Electric Power Company Holdings, Inc.

FDR2022, Fukushima J-Village

General information

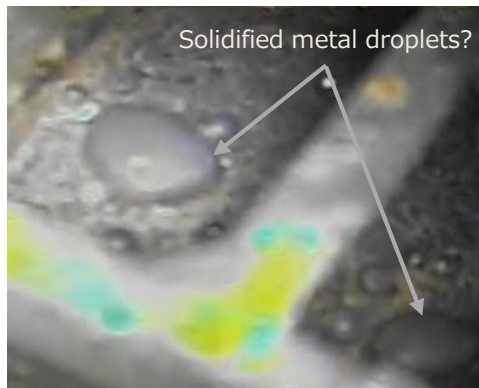
What could contribute to the amount of deposits?

- Lead shielding and Zn galvanized grating from all D/W area (relatively small amount)
- Piping insulation materials?
- Materials coming from the pedestal area through the 1st floor opening?

Has to be considered to correctly distinguish and evaluate the spread of molten core

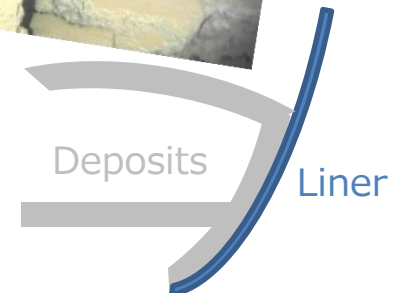
Formation of cavities and shelves

- Collapsed shelves seemingly forming one layer before
- Upper shelf coupled with the lower near liner
- No visible deformation of jet deflectors, PLR piping or support structures
